# Environmental Monitoring of Darial Hydropower Plant Construction and Operation

## Botanical Component

The first phase of the monitoring of the botanical component of the Darial hydropower plant construction and operation was carried out on 18 August, 2015

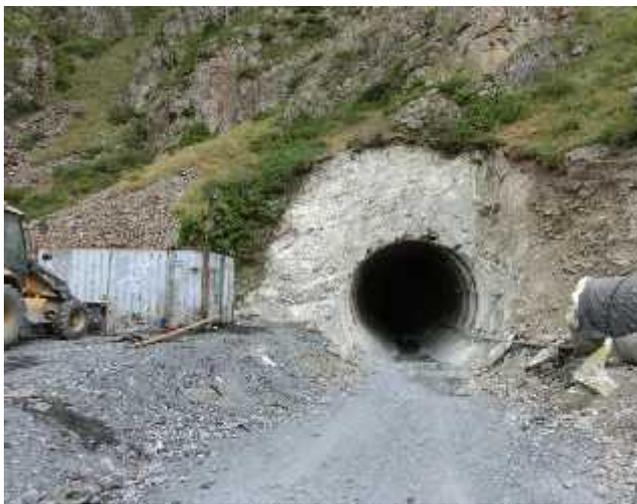
**Site 1.** GPS coordinates 0471239/4725694, 1689 m above the sea level, the tunnel south portal areas ( at the “Rock Feet”). The situation has not changed substantially. On the top of the portal, on the cliffs there grows *Juniperus depressa*. On the area adjacent to the portal, in the south-eastern slope there is just the initial stage of grassing. Out of pioneer plants there grow *Artemisia absinthium*, *Fumaria scheicheri*, *Verbascum* sp., *Cirsium* sp., *Salvia verticillata*, *Polygonum convolvulus*, *Sedum oppositifolium*, *Melandrium boissieri*.

**Site 1.** Areas of the southern portal of the tunnel

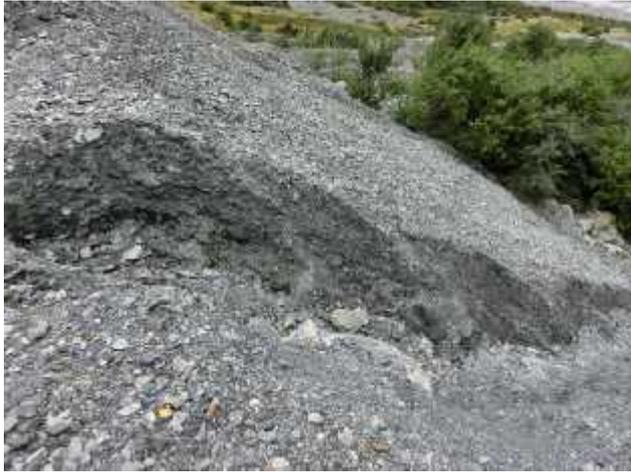
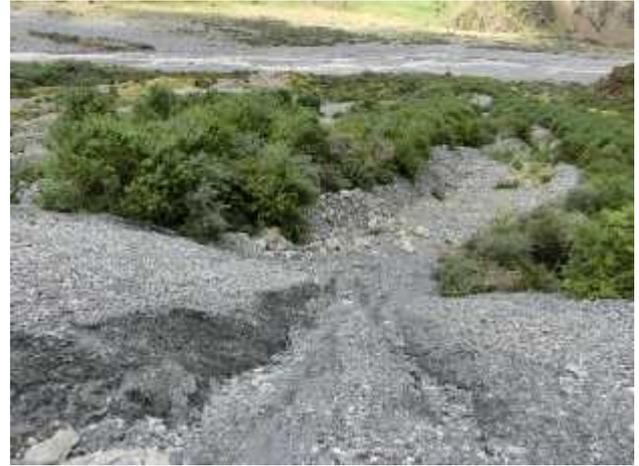
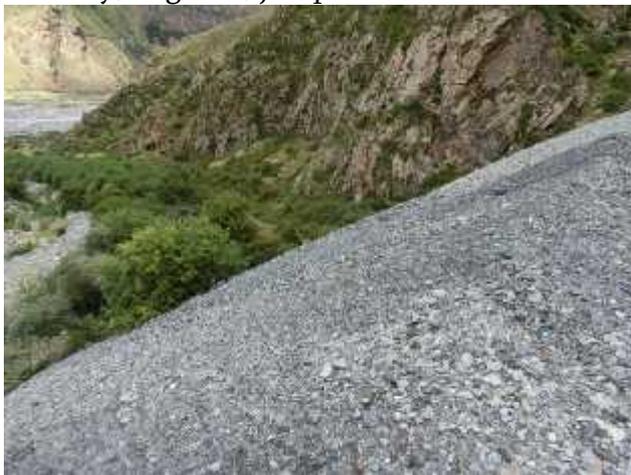
**Site 2.** GPS coordinates 0471193/4725653, 1693 m a.s.l., the portal surrounding areas. West exposure, slope  $-30-35^{\circ}$ . The slope below the newly laid road (which is made above the power conduit). No vegetation is seen yet in this area, so the pioneer plants are not growing. In the areas after the construction and in the natural (landslide) gravel flows there are remained sea buckthorns in kind of small isles, where goat willow (*Salix caprea*), barberry (*Berberis vulgaris*), dog rose (*Rosa canina*), juniper (*Juniperus depressa*, *J. sabina*) interfere.

**Site 2.** Sea buckthorns represented in the natural (landslide) gravel flows in kind of small isles with interfered goat willow, barberry, dog rose, juniper

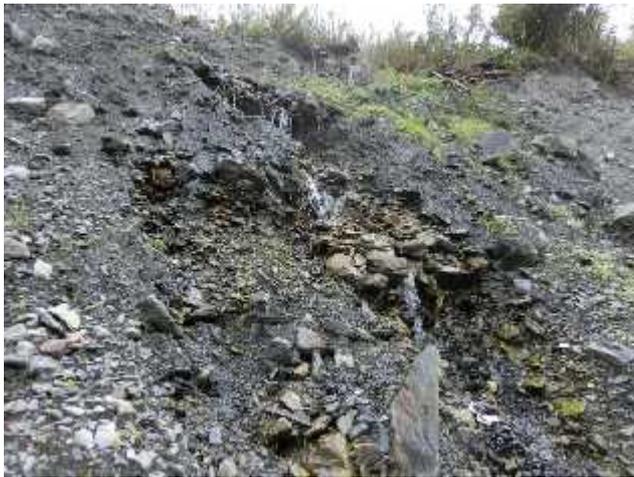
**Site 3.** GPS coordinates 0471229/4725553, 1696 m a.s.l. West exposure, slope  $-35^{\circ}$ . The pioneer phase of vegetation restoration on the rocky soil after construction of the power conduit, which is represented by the following plant species: *Bromopsis variegata*, *Artemisia absinthium*, *Trifolium ambiguum*, *Mentha longifolia*, *Poa pratensis*, *Cirsium* sp.

Site 3. The pioneer phase of vegetation restoration on the rocky soil after construction

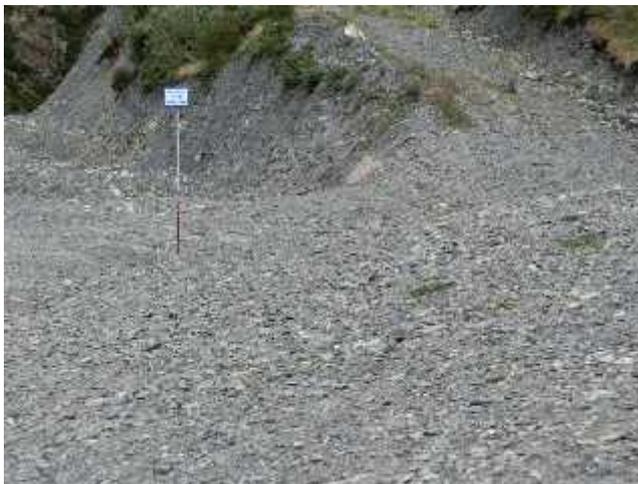
Site 5. GPS coordinates 0471265/4725318, 1699 m a.s.l. West exposure, slope -15-20°. The grass artificially seeded and grown up should be *Poa* sp. On the upper slope of the conduit way on the gravel soils after construction there are grown the pioneer species: *Leontodon hispidus*, *Moehringia trinervia*, *Trifolium ambiguum*, *Polygonum aviculare*, *Plantago saxatilis*, *Carduus onopordioides*, *Capsella bursa-pastoris*.

Site 5. Upper slope of conduit way

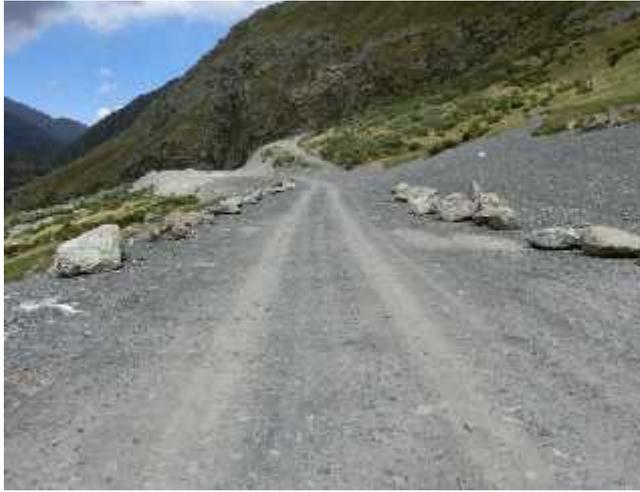
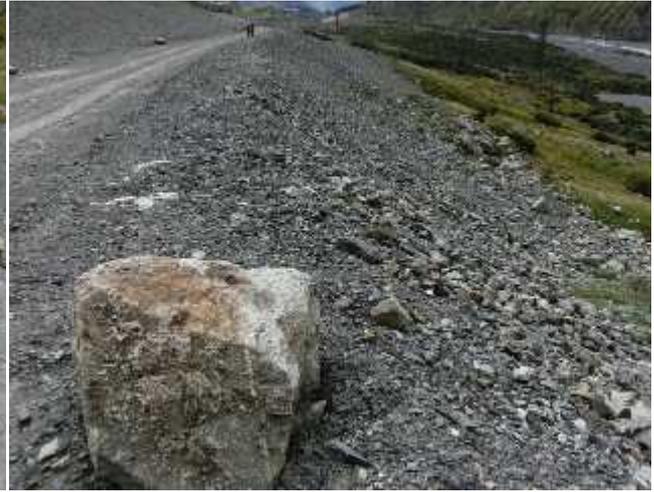
**Site 6.** GPS coordinates 0471244/4725217, 1701 m a.s.l. The section from the gas pipeline (where big stones are dumped). The same situation as in the previous site. The photos represent the upper and lower slopes of the conduit way.

**Site 6.** Upper and lower slopes of the conduit way

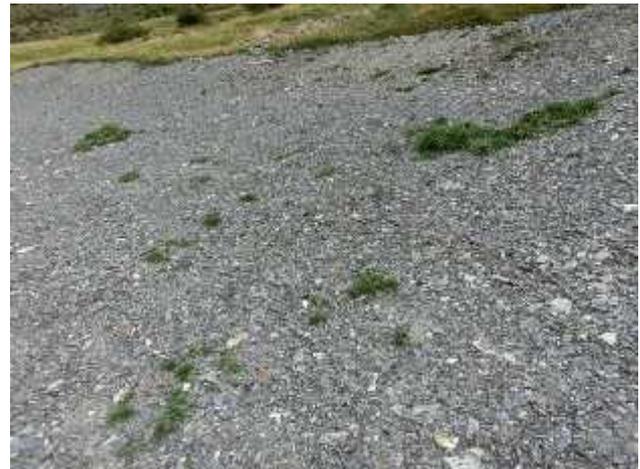
**Site 7.** GPS coordinates 0471216/4725010, 1704 m a.s.l. The situation similar to the two previous sites. The natural meadow turfs occupy the slope which are located as the landslide isles. The plant species are: *Taraxacum officinale*, *Agrostis planifolia*, *Bromopsis variegata*, *Festuca pratensis* and other.

**Site 7.** Natural meadow turfs occupying the slope as landslide isles

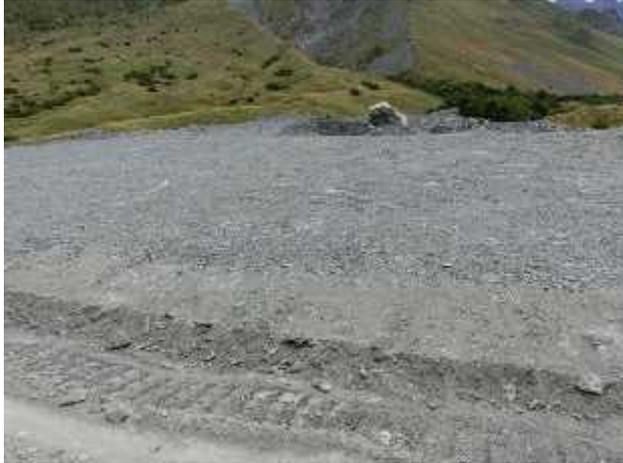
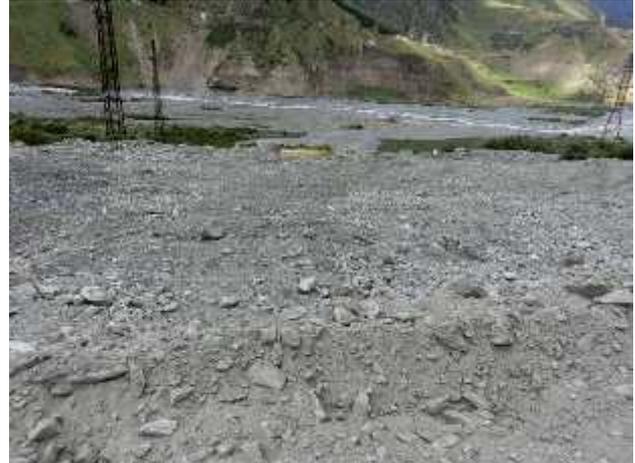
**Site 8.** GPS coordinates 0479162/4724777, 1707 m a.s.l.. West exposure, slope 15-20°. The debris cone leveled by the machines above the road, the road below is the filled with stone-gravel soil. Pioneer plants have not been yet settled here. Artificial seeding is possible, though it is a landslide hazardous zone and development of mudflow and landslide processes is expected.

**Site 8.** Filled stone-gravel soil

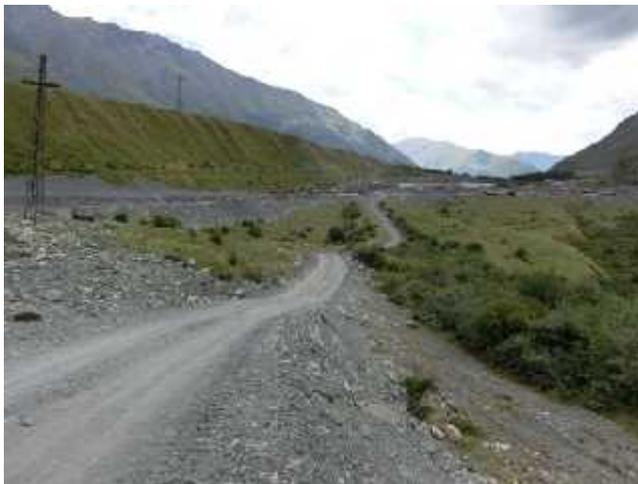
**Site 9.** GPS coordinates 0471173/4724502. 1703 m a.s.l. The sedimentation research is seen from this place. The situation at the conduit way is similar to the previous sites – the initial phase of vegetation restoration with pioneer plants. On both sides of the lower access road the natural vegetation is not damaged, where sea buckthorns and subalpine meadows are developed.

**Site 9.** The initial phase of vegetation restoration with pioneering plants.

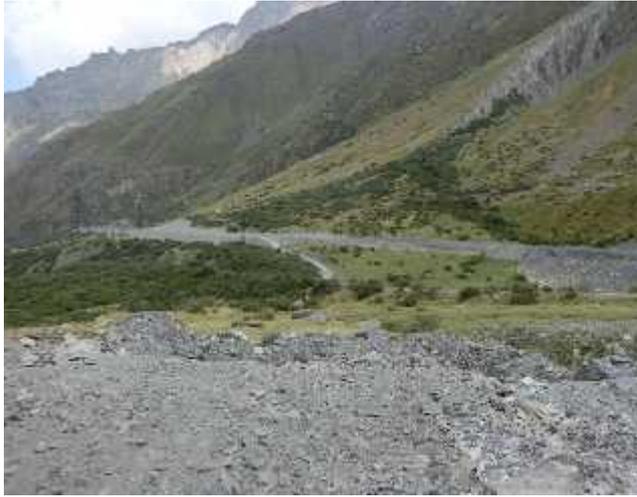
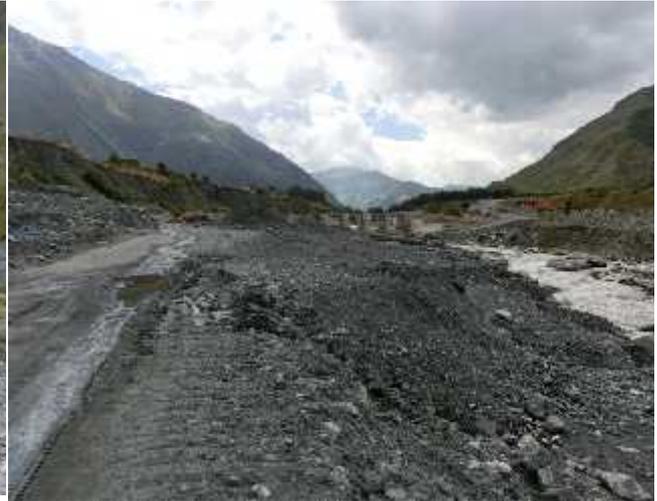
**Site 10.** GPS coordinates 0471022/4724128, 1708 m a.s.l. The area near the sedimentation research. The vegetation restoration has not started yet here. The photo represents the panorama of the whole conduit – from the sedimentation research to the portal.

**Site 10.** Total conduit from the sedimentation research to the portal

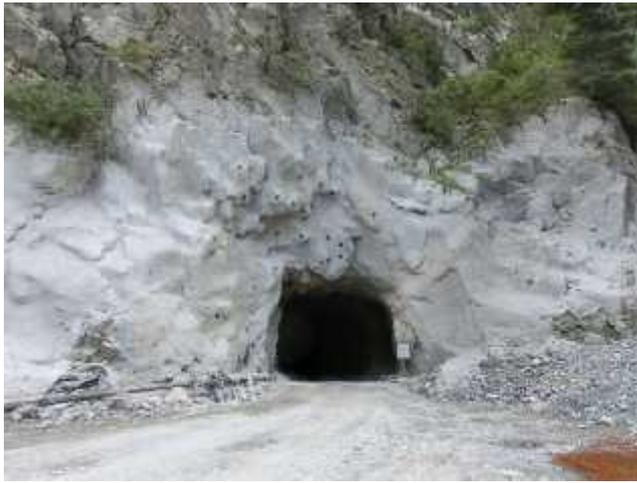
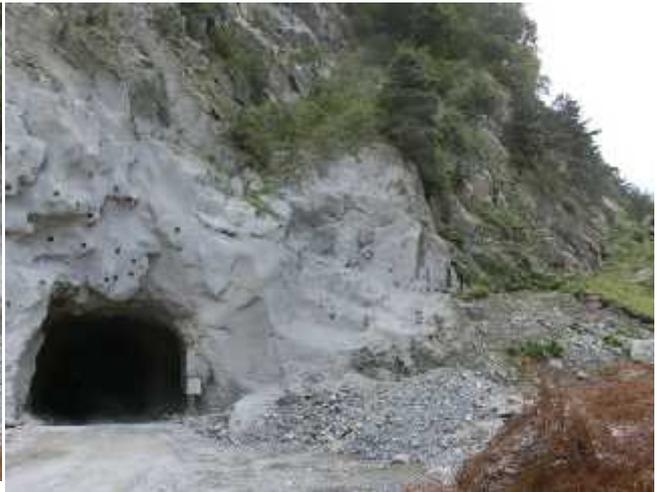
**Site 11.** GPS coordinates 0469839/4730954, 1370 m a.s.l. North exposure, slope 90°. The north portal of the Lars HPP conduit. Northern portal. The vegetation round the portal is destroyed. The vegetation of the adjacent cliff is preserved. .

**Site 11.** Petrophilous vegetation adjacent to the portal

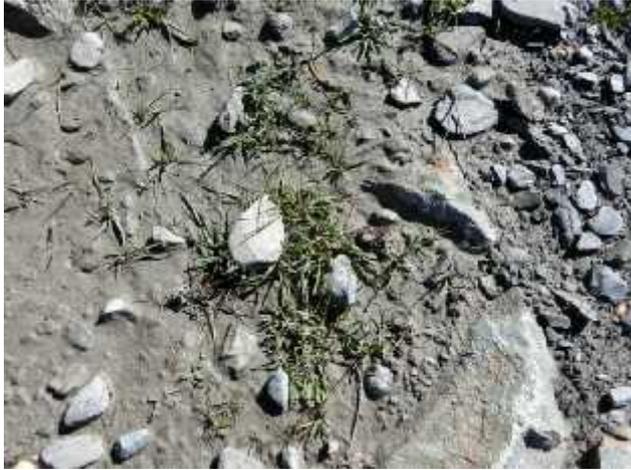
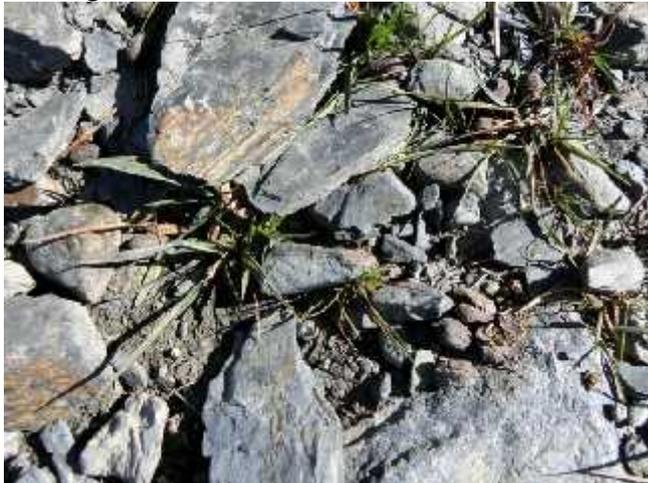
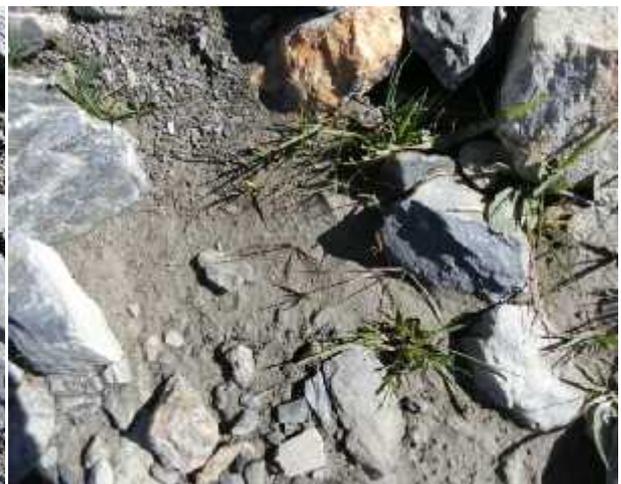
**Site 2.** Where vegetation was not seeded, the pioneer plants do not grow. Out of naturally seeded *Plantago saxatilis* is on the first place. Here and there *Cirsium echinus* rosettes are present. .

**Site 2.** Pioneer plants resulted from artificial seeding

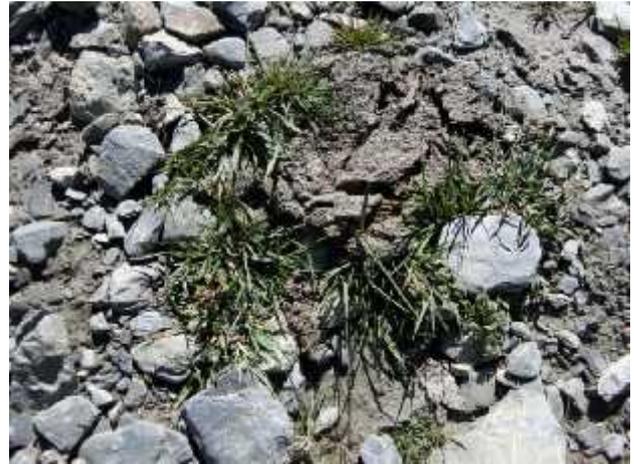
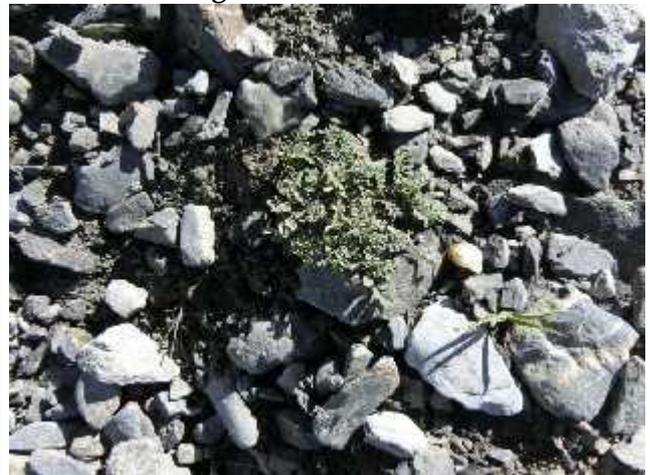
**Site 3.** In this section the sheep grazing is a hindering factor. The sheep paths and grazed pioneer plants are seen on the slopes.

**Site 3.** Pioneer plants resulted from the artificial seeding

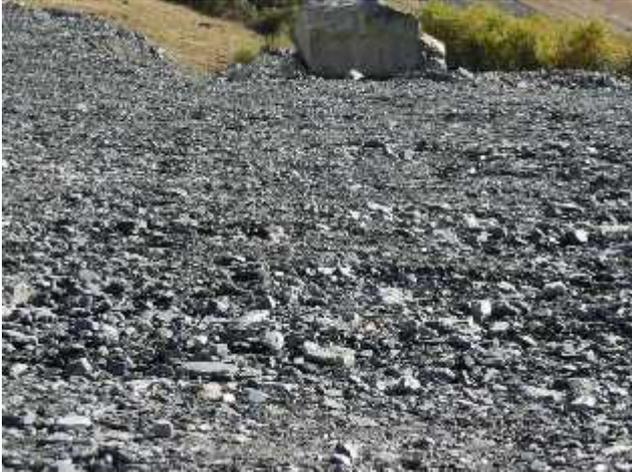
**Site 4.** Further south, in the mudflow-erosion gully area (below the large stone), there is growing no pioneer plant because not long ago this area was still under construction (soil

grading) – here we see a stable stone-gravel soil (sterile artificial debris). In the future here the vegetation restoration processes is expected by natural and artificial way.

**Site 4.** Sterile artificial debris

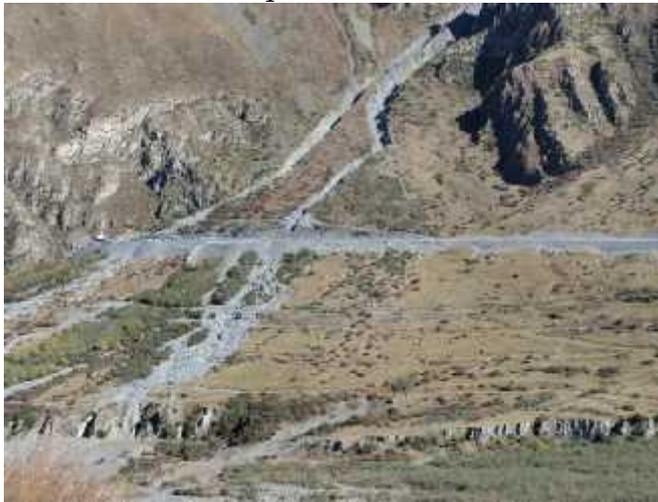
Site 5. Erosive ravines
