Blue Rivers®
Environmental
Consulting

Implementation of the Post-Commissioning Monitoring of Dariali HPP in 2017

Final Report

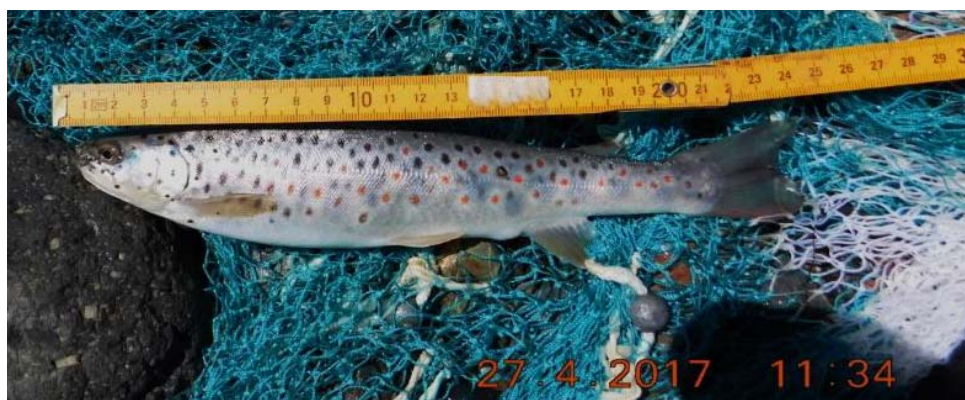
Figure 2. Caught trout at M 3 in spring

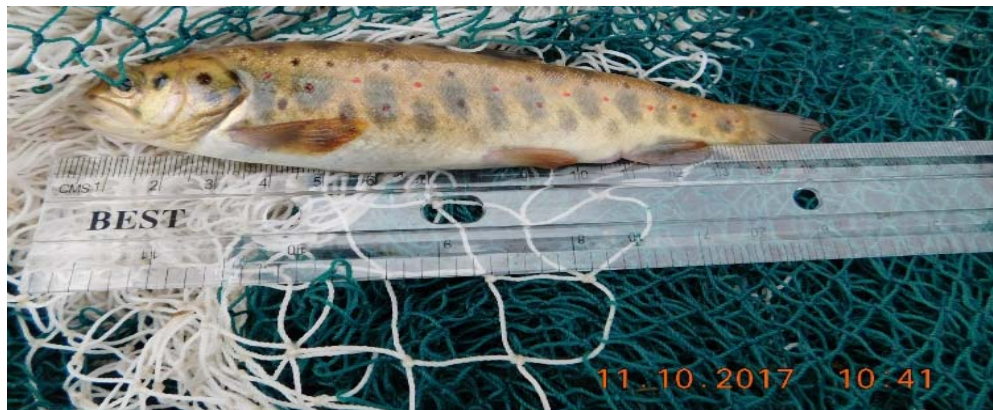
Figure 3. Caught trout at M 3 in autumn

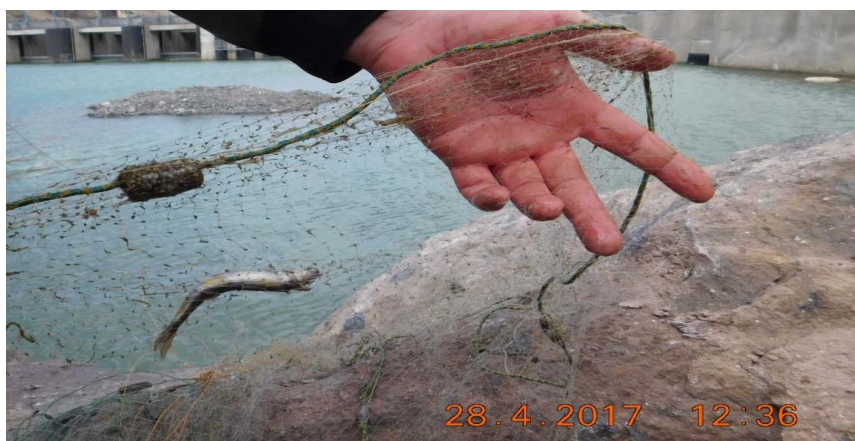
In spring, the study was conducted using echo depth-sounder, bottom gill net and casting net. In total, 27 attempts by the casting net were done along the whole perimeter of water reservoir. 3 brown trout specimen were caught: 2 in upper right corner of the water reservoir and 1 - in left corner of water reservoir. During two days, bottom gill nets of the size 20 m long and 1,5 m high and size of the mesh a-15 and a-10 mm were installed. 1 trout specimen was caught in the net with the mesh size a-10 (Figure 4).

Figure 4. Caught trout by bottom gill net

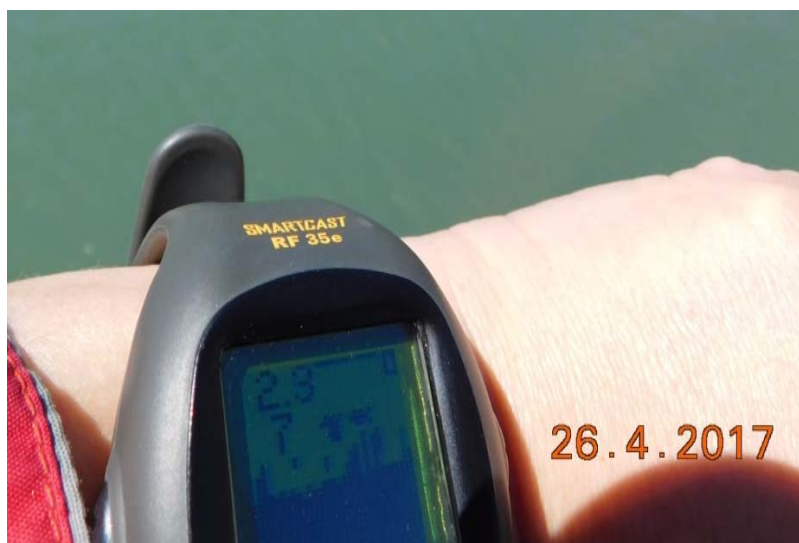
Figure 5. Study of the fish distribution using echo depth-sounder

During the study of the fish distribution in the water reservoir using echo depth-sounder, the biggest number of trout (5-8 specimen) were fixed in right upper corner (Figure 5). Also a few specimens were fixed at the entrance of the river into water reservoir and a bit upstream the water reservoir backwaters.

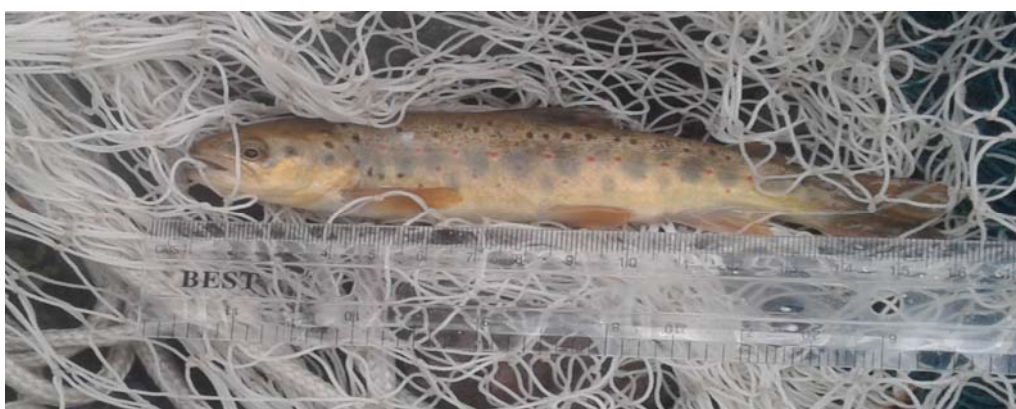
In autumn, 24 catching attempts were done along the whole perimeter of the water reservoir. In total, 4 specimens of the brown trout were caught: 2 – in right upper corner of the water reservoir and 2 – in left upper corner of the water reservoir (Figure 6).

Figure 6. The brown trout caught by casting net in the water reservoir in autumn

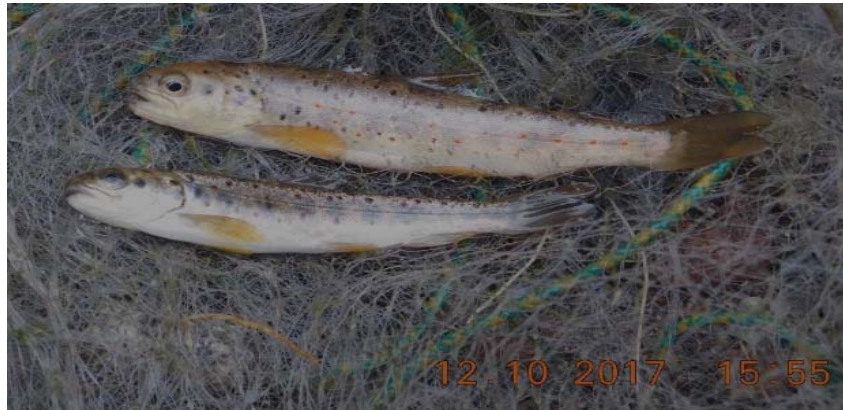
2 daily placements of roe net with the size of 20 m long and 1.5 m height with mesh size a-15 and a-10 mm were placed in upper corner of the water reservoir. In total, 2 specimens of the brown trout was caught by the net with mesh size a-10 (Figure 7).

Figure 7. Caught brown trout in the water reservoir

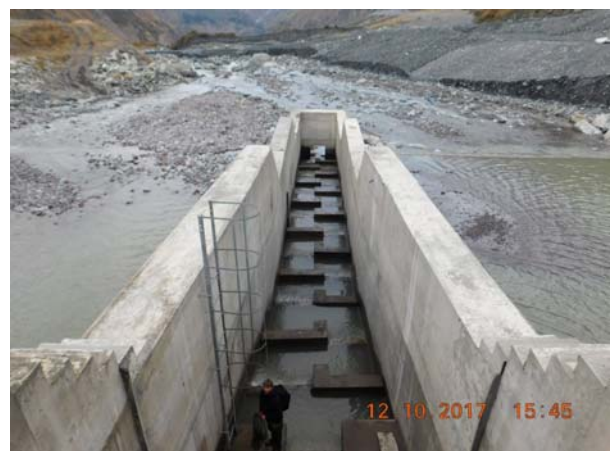
Figure 8. Clean fish pass with the ladder

- The fish pass was cleaned from the construction garbage; the metallic pins were removed (Figure 8).
- The ladder was installed to go down to the fish pass, which allows cleaning the fish pass and fish monitoring (partial drying – “blocking method”).

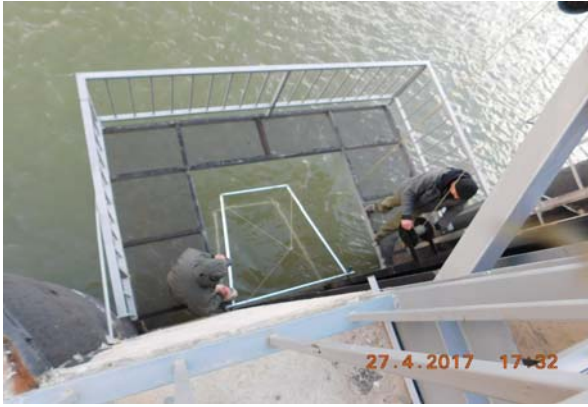
Figure 9. Driving pulley and winch

- The Dariali HPP installed driving pulley and winch above the ichthyologic platform, needed to put up and down the fish trap more comfortably (Figure 9).
- Prior the start of the autumn surveys, the changes were made in binding the fish trap. The welded four switches were replaced with the new ones taking into account the recommendations of Consultant.

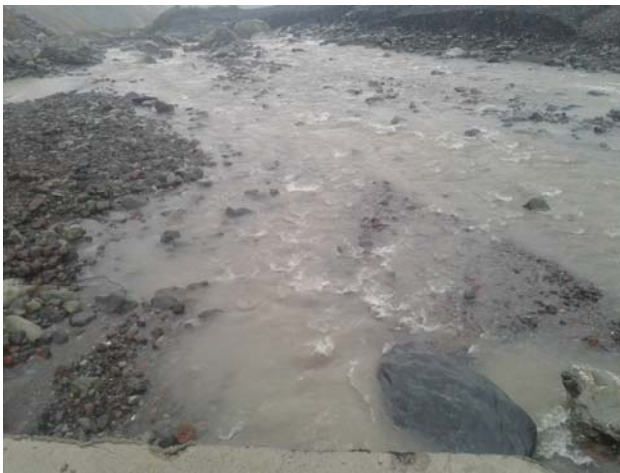
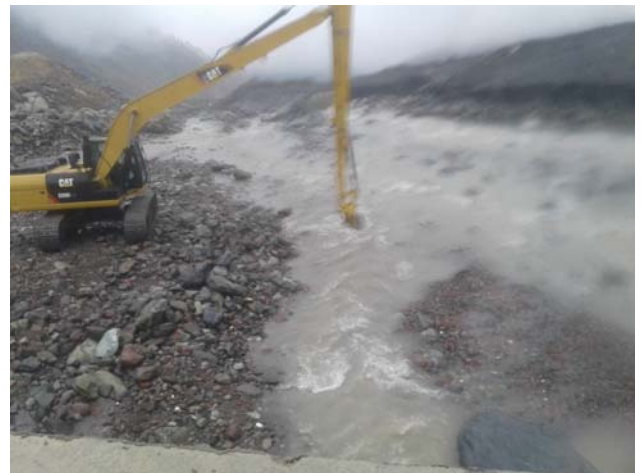
Figure 10. Deepening of the entrance for fish in the lower reach of the fish pass

- The inner barrier of ichthyologic platform was not done to ensure comfortable and safe monitoring. This inner barrier is important for work safety and to prevent falling of the specialists into the opening of the platform. The barrier will not complicate the fish trap extraction; moreover, it will be more comfortable to put the extracted trap at the handrails of the inner barrier instead of putting it on the floor.
- Prior the autumn surveys, the recommendation of the Consultant regarding deepening of the entrance for fish in the lower reach of the fish pass was not implemented.

This operation was done on request of the Consultant by Dariali HPP personal two days after the start of the monitoring works (Figure 10).

Conclusions: it is recommended to complete the last two technical requirements of the Consultant on the vertical switches and inner barriers at ichthyologic platform to ensure effective and safe operation

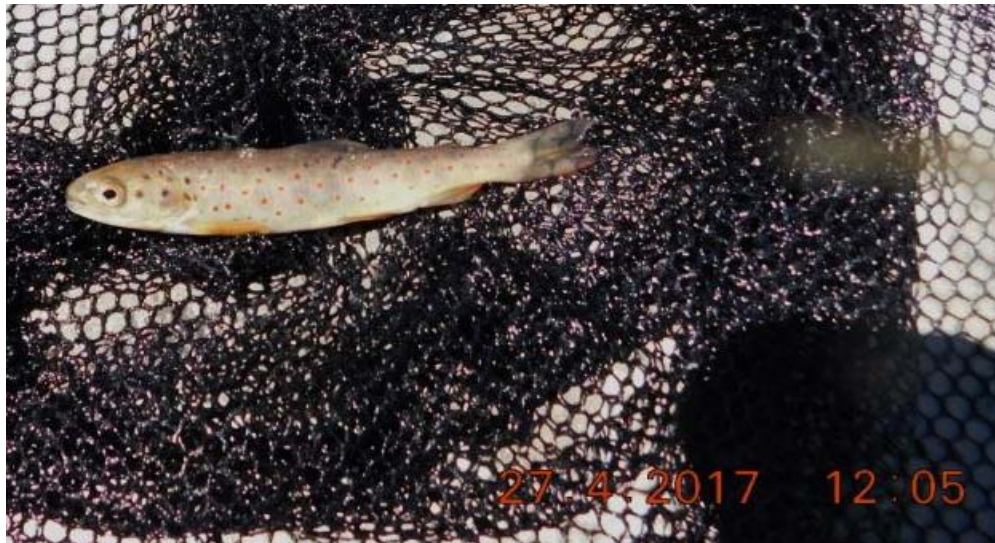
During the drying out of the fish pass at 4th step from down, the trout with the body length 11.5 cm was caught by ichthyologic net (Figure 11). This confirms that migrating fish uses the fish pass.

Figure 11. Caught trout in the fish pass

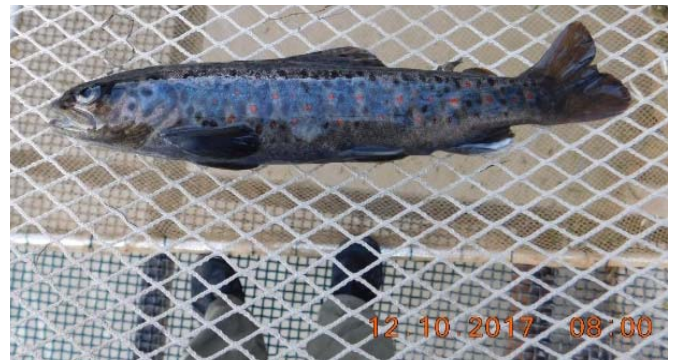
The first trout was caught at 6th placement at 11-12 October from 17:30 till 8:00. It was ready for spawning male trout. It is worth to mention that the specimen had darker color comparing with dominating trout in Tergi (Figure 12).

Figure 12. Caught male trout by the fish trap (6th time)

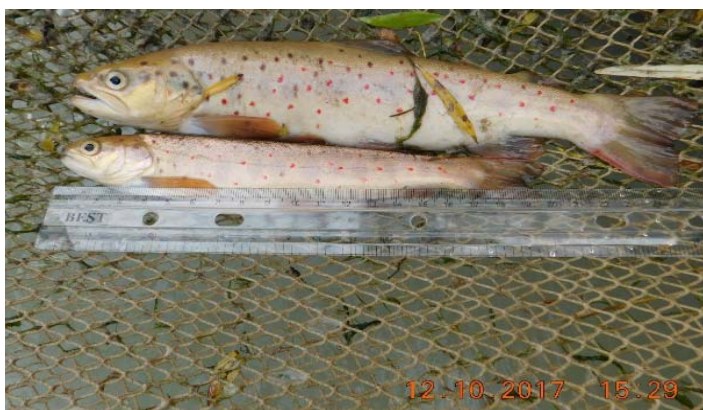
Figure 13. Caught male trout by the fish trap (7th time)

7th placement done on 12th of October from 8:30 to 16:00 brought two male trout ready for spawning (Figure 13).

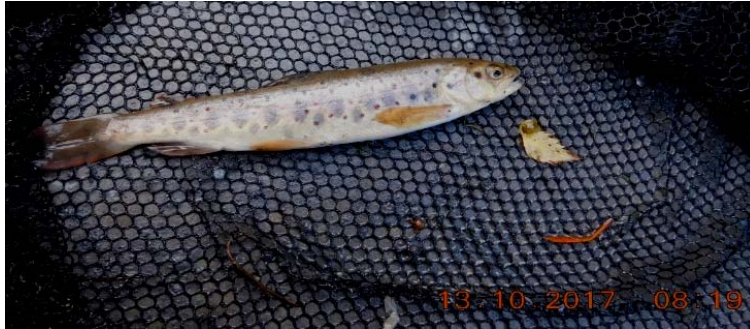
On 13 October at 8:20 at the 3rd step from down, the trout was caught with the length 11,5 cm (Figure 14).

Figure 14. Caught trout by the fish pass drying

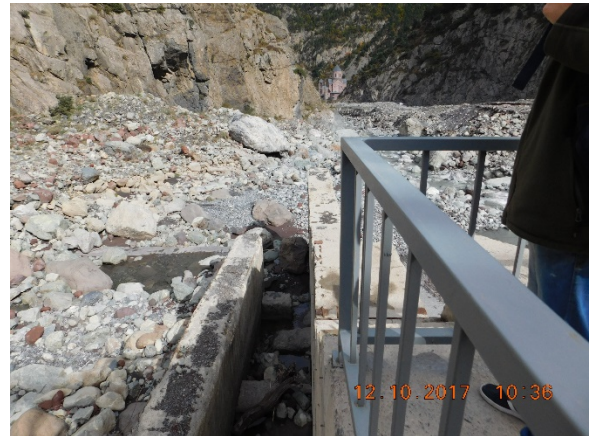
Figure 15. State of the fish pass at Larsi HPP

It is also important to have Larsi HPP fish pass operational to ensure the brown trout migration at Tergi. In spring and autumn, the fish pass at Larsi HPP was not operational (Figure 15).

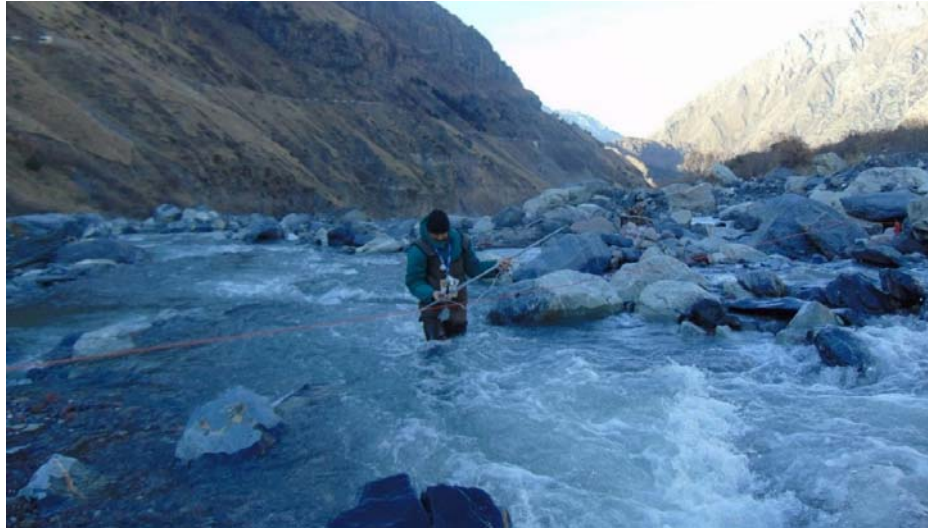
Figure 20. Tergi downstream the Dariali headwork (boulders section)

Within M 2, the riverbed type has been changed. Now it is braided channel type (Figure 20).

The average velocity was 0.43 m/s, with maximum 1.09 m/s. Flow types included chute, chaotic, broken standing waves, and unbroken standing waves.

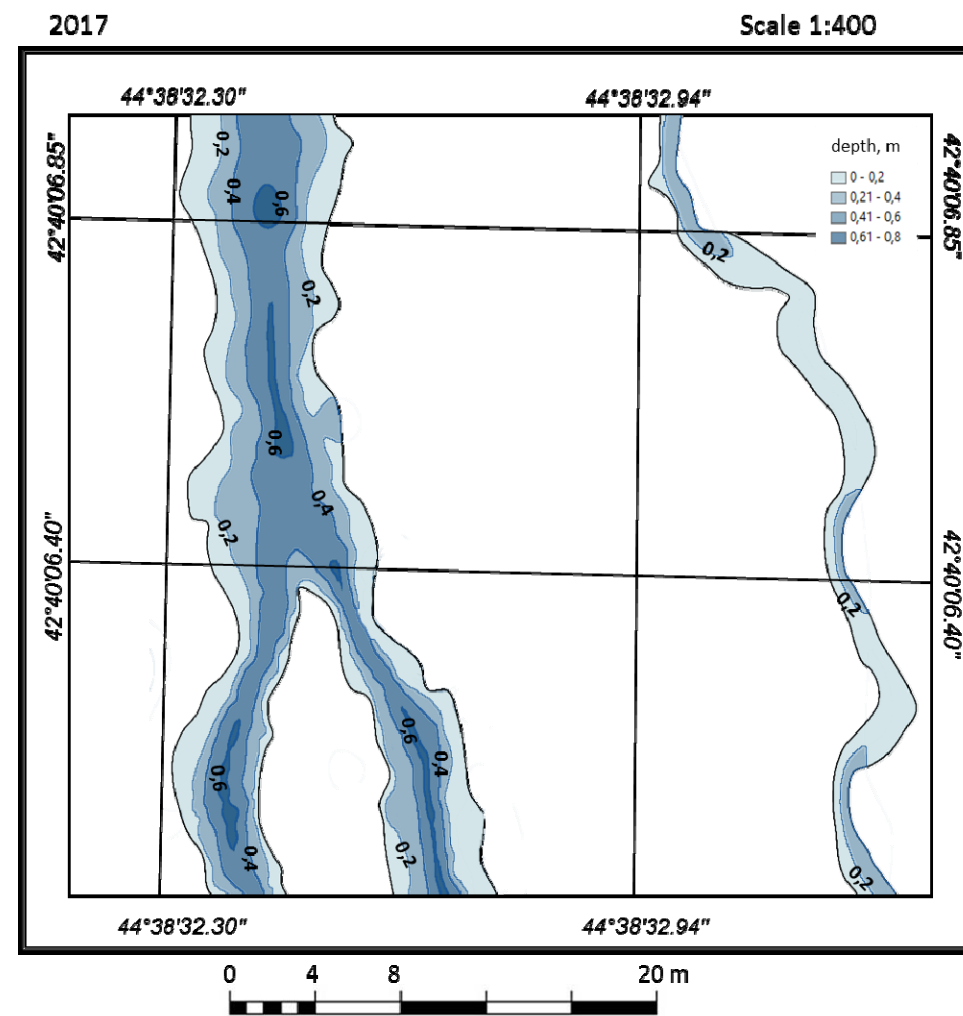
Figure 23. Isobaths (depths)

The comparative maps of the depths and velocities for this monitoring station are presented at Figures 23-24.

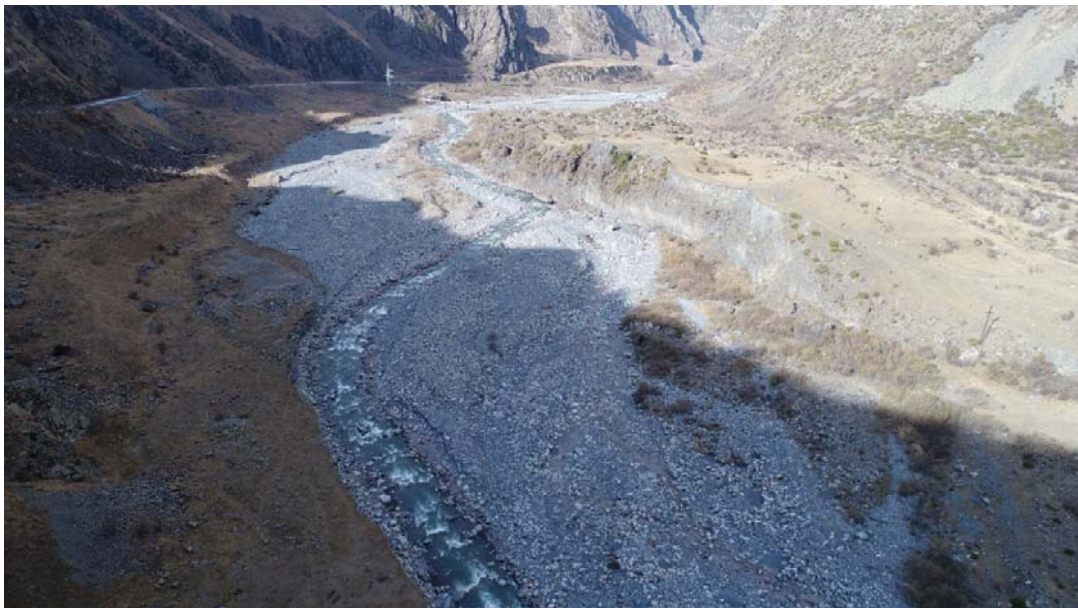
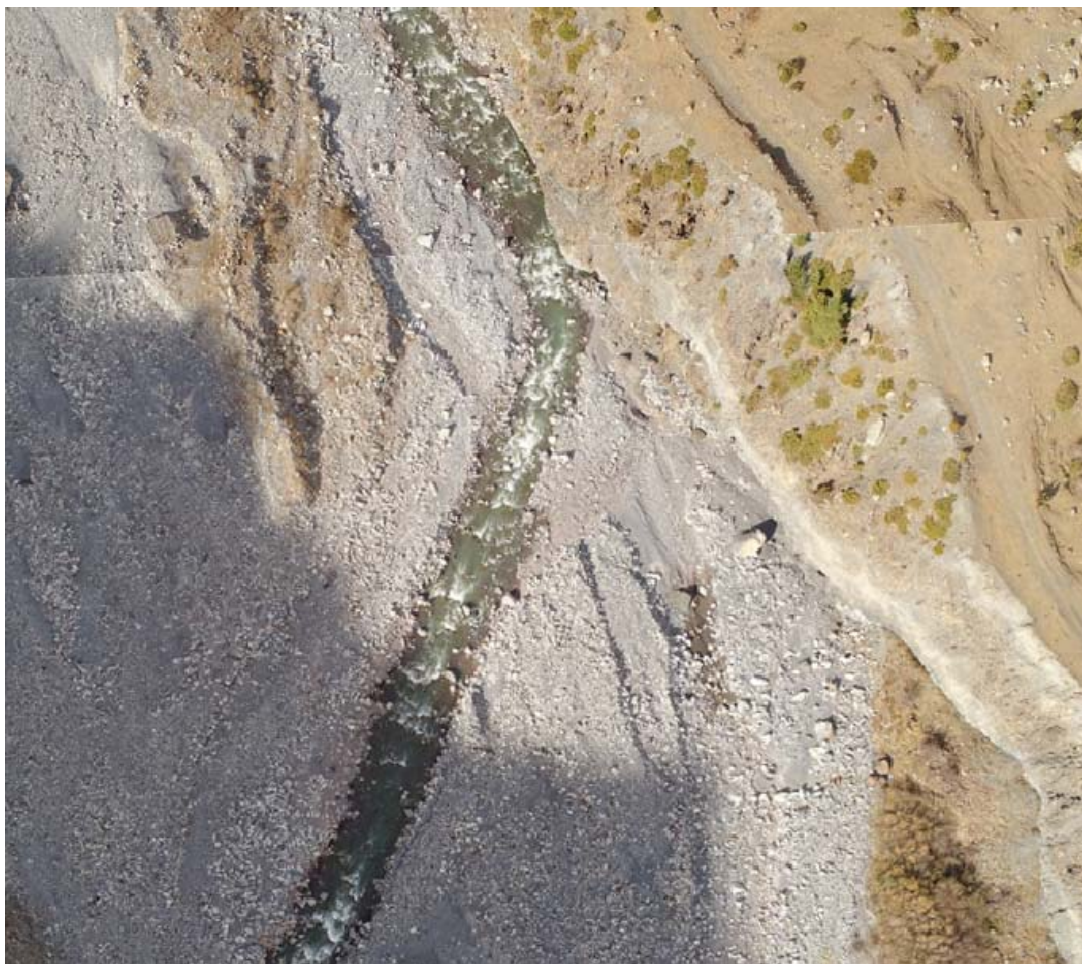
Figure 25. Tergi downstream the Dariali headwork (braided section)

Within M 3, the type has been changed, now it is single channel type. Only left arm is active.

The average velocity was 0.63 m/s, with maximum 1.02 m/s. Flow types included chaotic, broken standing waves, and unbroken standing waves (Figure 25). The average width of the river was 7.8 m, with maximum 9.2 m. Bed elements included rapids and rocks. The average velocity reduced by 0.28 m/s (31%), maximum reduced by 0.98 m/s (49%). The average width of riverbed reduced by 2.2 m (22%), maximum one - by 4.7 m (34%) (Figure 26). The average depth was 0.43 m with maximum 0.74 m. Ratio of average width of channel to the average depth was $C_b/h=18$. The average depth of the flow reduced by 0.04 m (9%), maximum one - by 0.26 m (26%) (Figure 26).

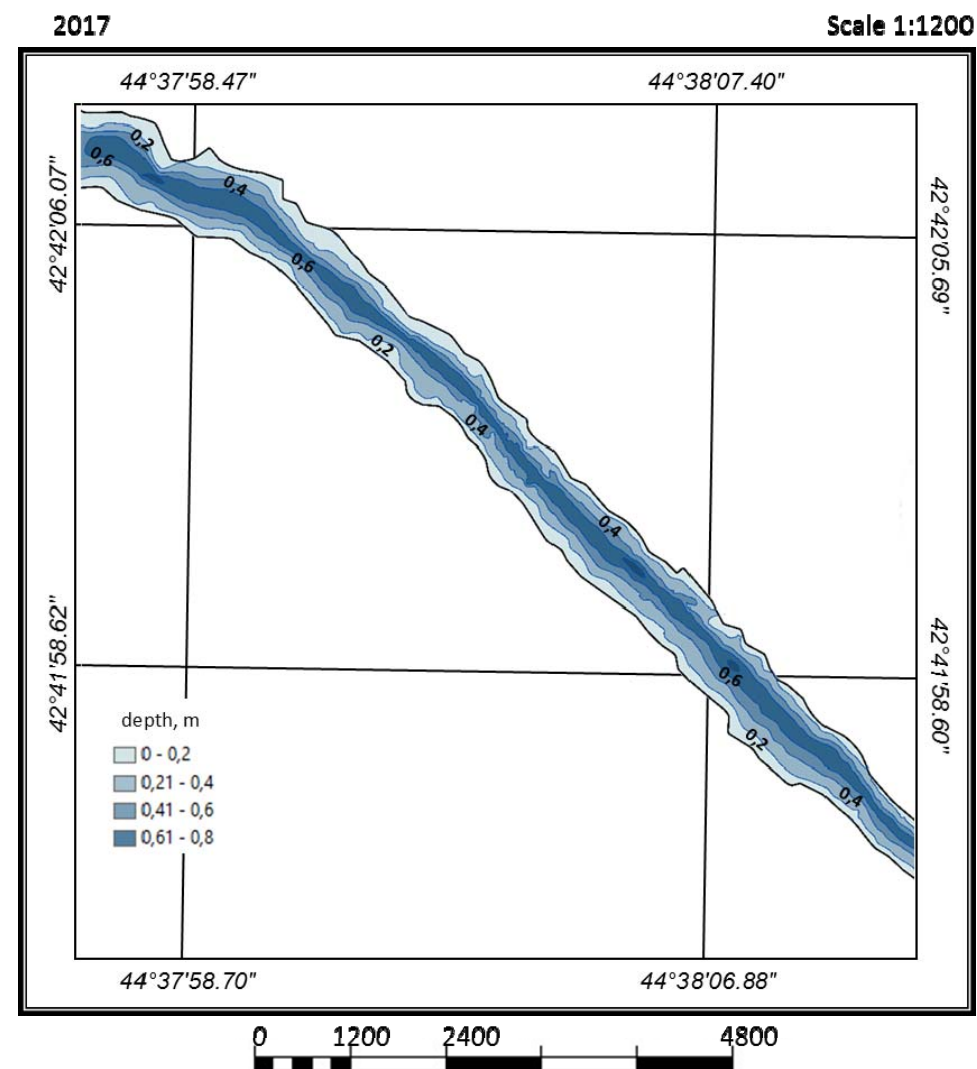
Figure 28. Isobaths (depths)

The comparative maps of the depths and velocities for this monitoring station are presented at Figures 28-29.

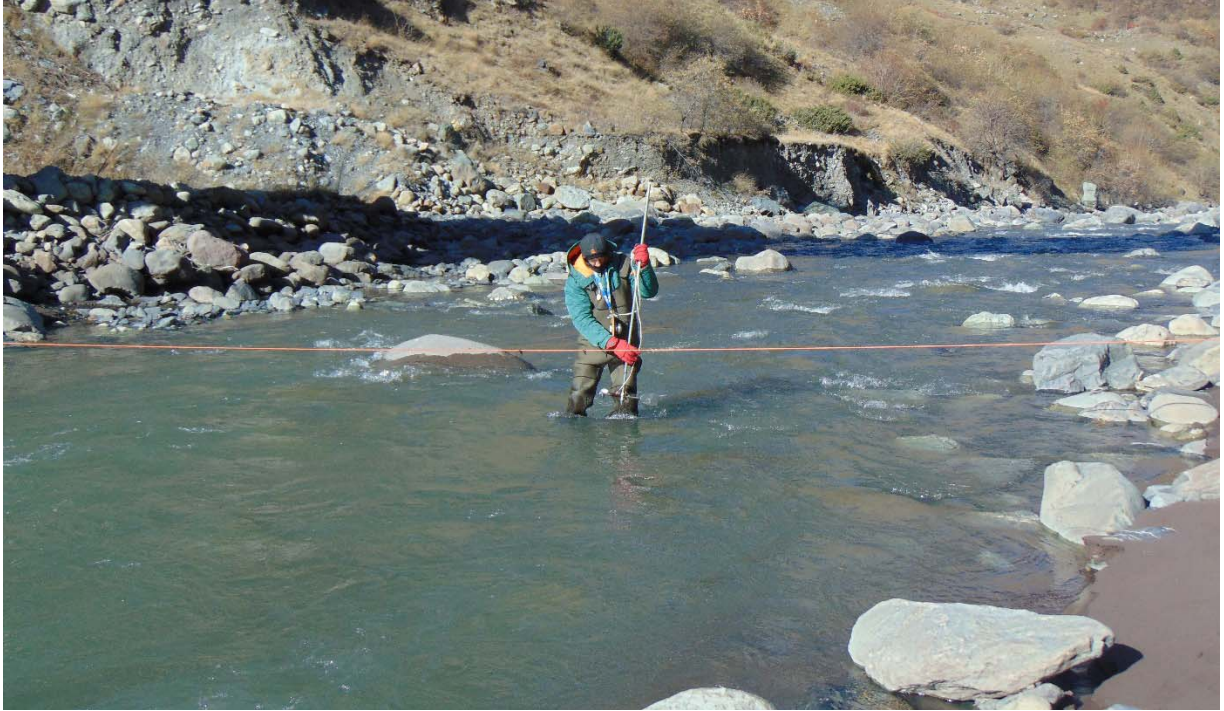
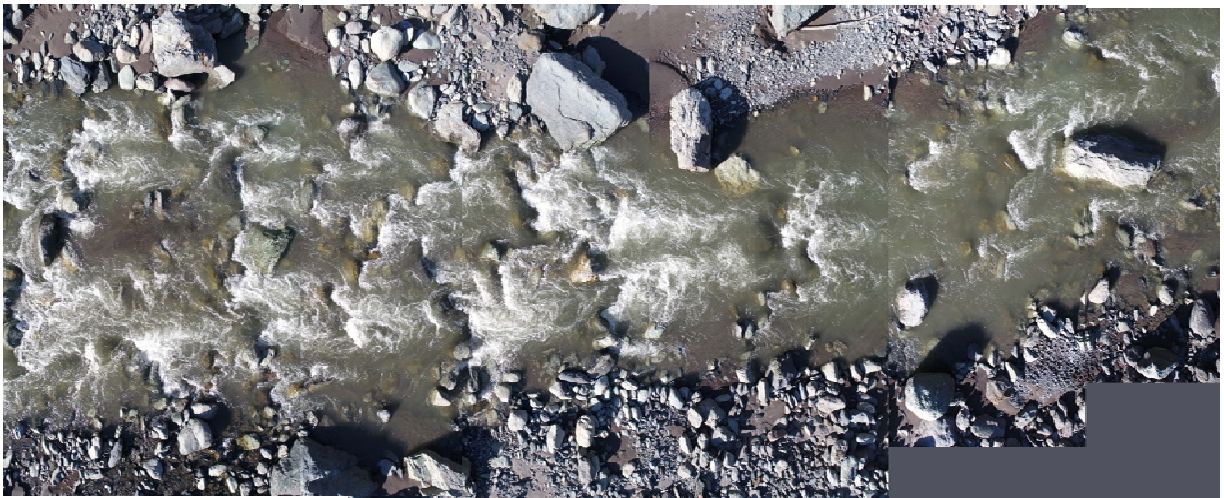
Figure 30. Tergi downstream the Dariali headwork (single section)

The average velocity was 0.57 m/s, with maximum 1.04 m/s. Flow types included chaotic, broken standing waves and unbroken standing waves (Figure 30).

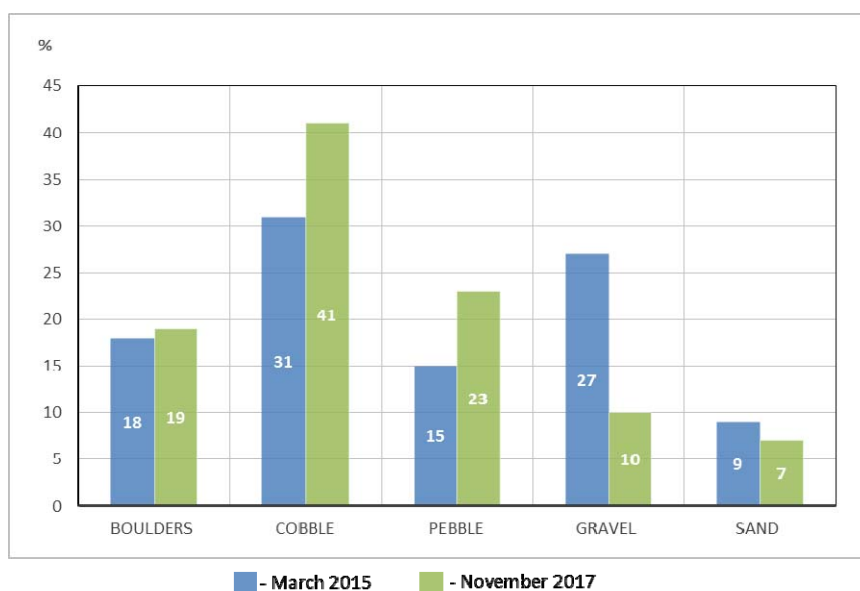
Figure 32. Distribution of the sediments, %

Both banks were made mainly out of cobble. The riverbed was evenly covered by cobble (41%) and pebble (23%).

The following changes in the sediment composition were observed: percentage of boulders, cobble and pebble increased by 1%, 10% and 8% accordingly. Percentage of gravel and sand get reduced by 17% and 2% accordingly (Figure 32).

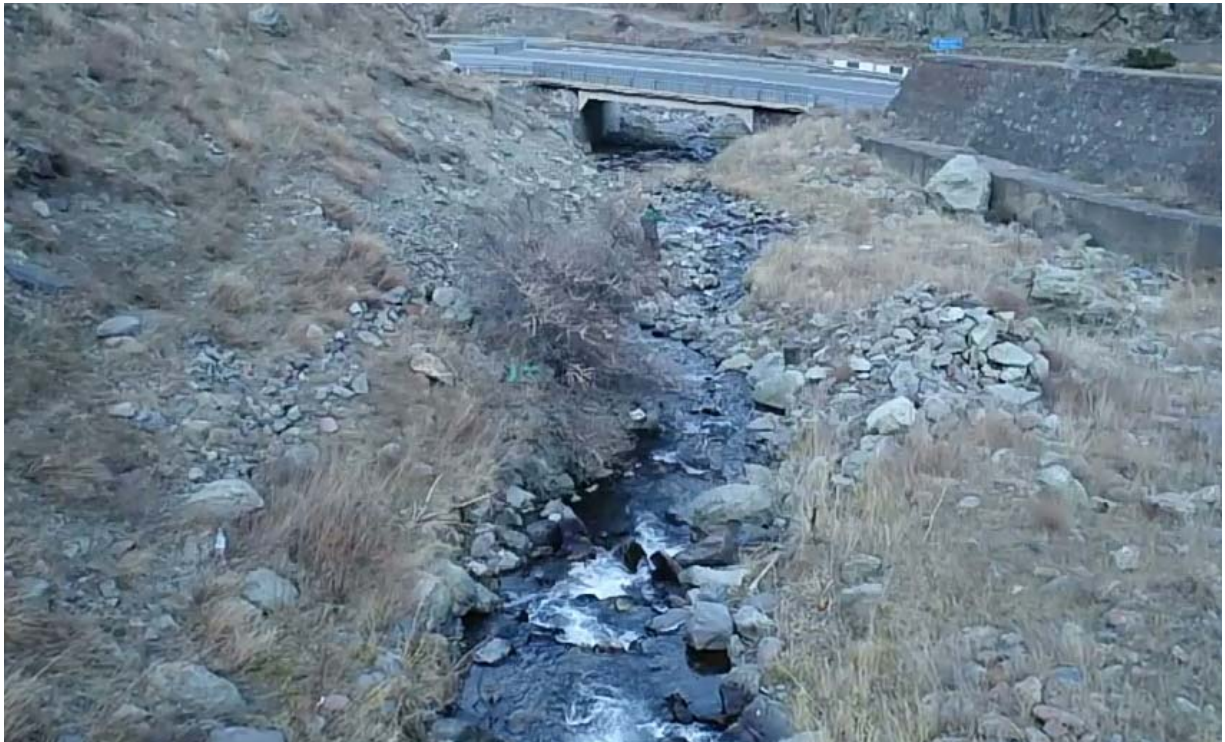
Figure 35. Tibistkali mouth

The average velocity was 0.47 m/s, with maximum 0.95 m/s. Flow types included chute, chaotic, broken standing waves, and unbroken standing waves (Figure 28).

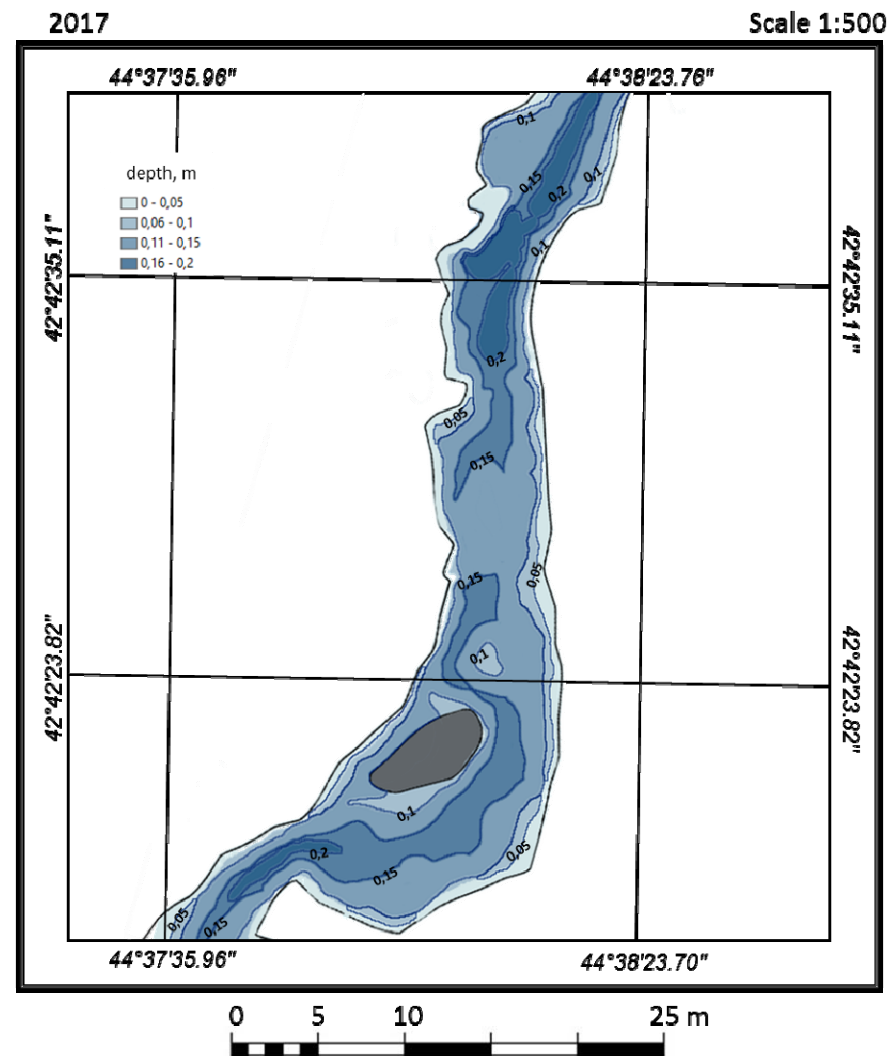
Figure 38. Isobaths (depths)

The comparative maps of the depths and velocities for this monitoring station are presented at Figures 38-39.
