Project “Development and Implementation of Aquatic Biodiversity Action Plan for Dariali HPP”

Aquatic biodiversity: monitoring results in 2016 and mitigation measures proposed

Report

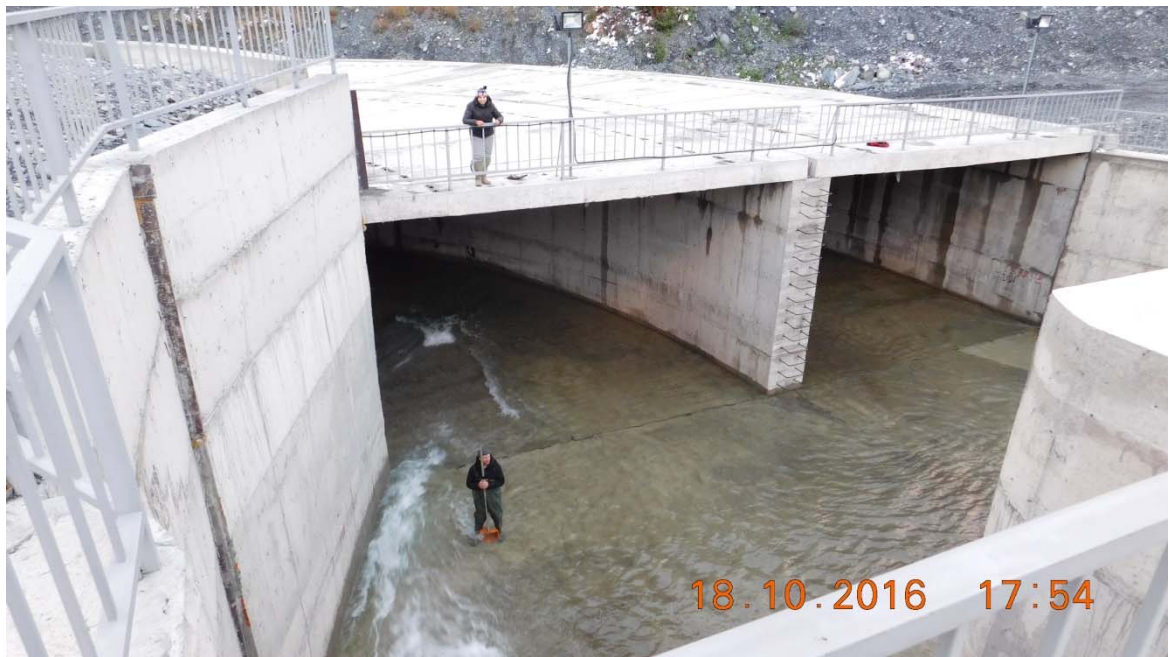
Figure 2. Sampling of drifting invertebrates near sand traps

Intensity and composition of drift corresponds to seasonal dynamics defined in 2015. In conditions of partly opened sluices at the stations, drift of invertebrates into the sand tank was in appr. 100 times smaller comparing to natural drift in the riverbed (Figures 2 and 3).

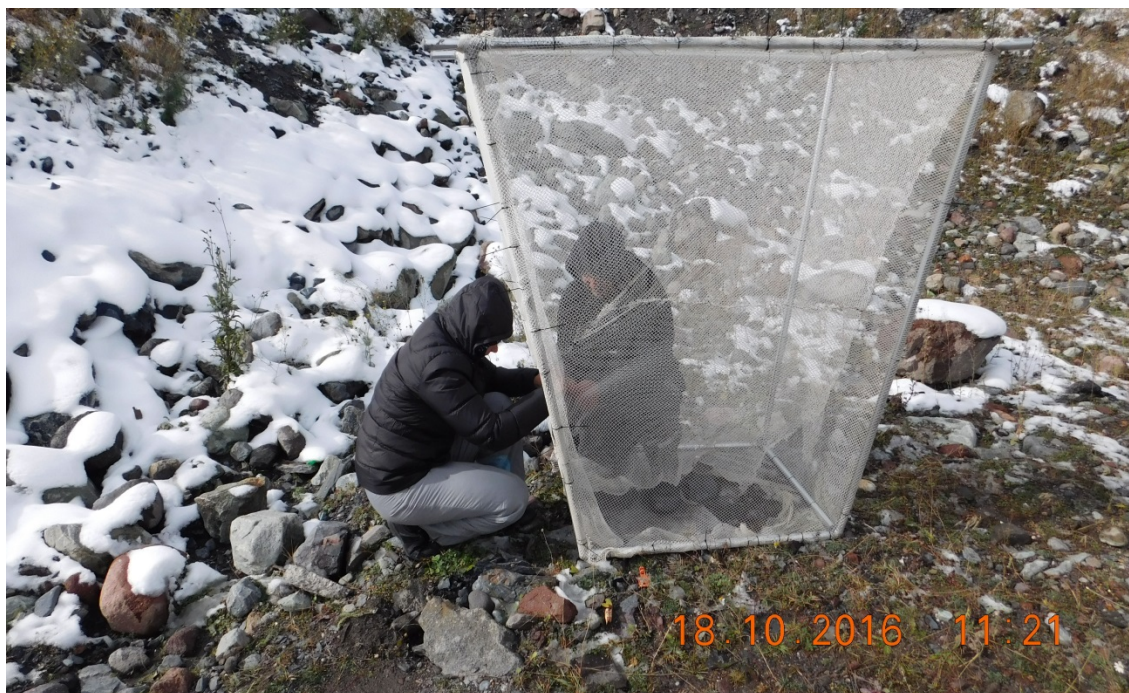
Figure 4. Fish trap

The fish trap framework for monitoring of fish pass was constructed according to the scheme provided by the Consultant. The hooks for fish trap instalment in the upper reach of Dariali HPP were welded at the fish pass in-take. During the autumn survey, the fish trap was finalized by the efforts of Consultant by covering it with nylon net (Figure 4).

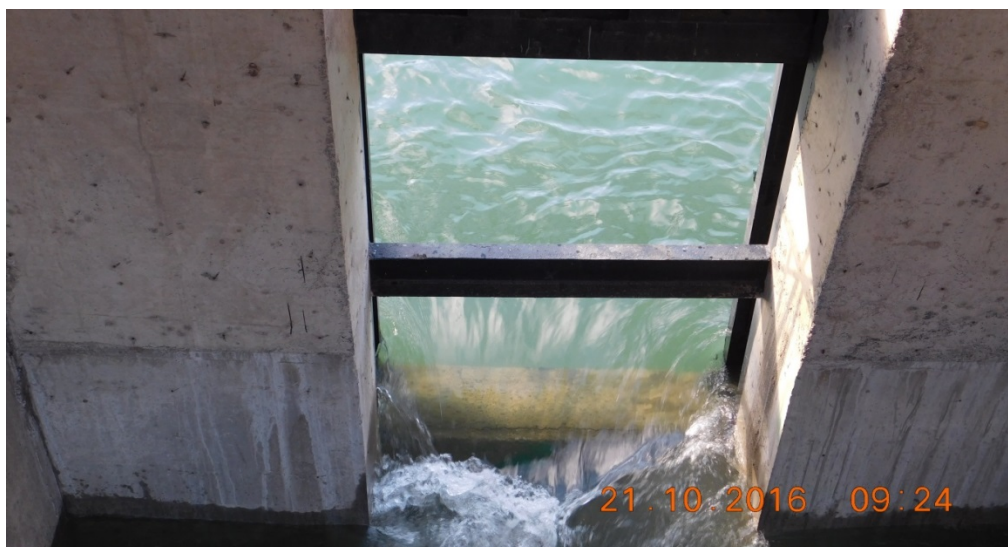
Figure 5. Fish pass in the operational mode

During the autumn field surveys, the water level in upper reach of the Dariali HPP was not sufficient for watering the fish pass. Following the request of the Consultant, the water level was levelled up to working mode, which allowed testing the fish pass in operational mode (Figure 5).

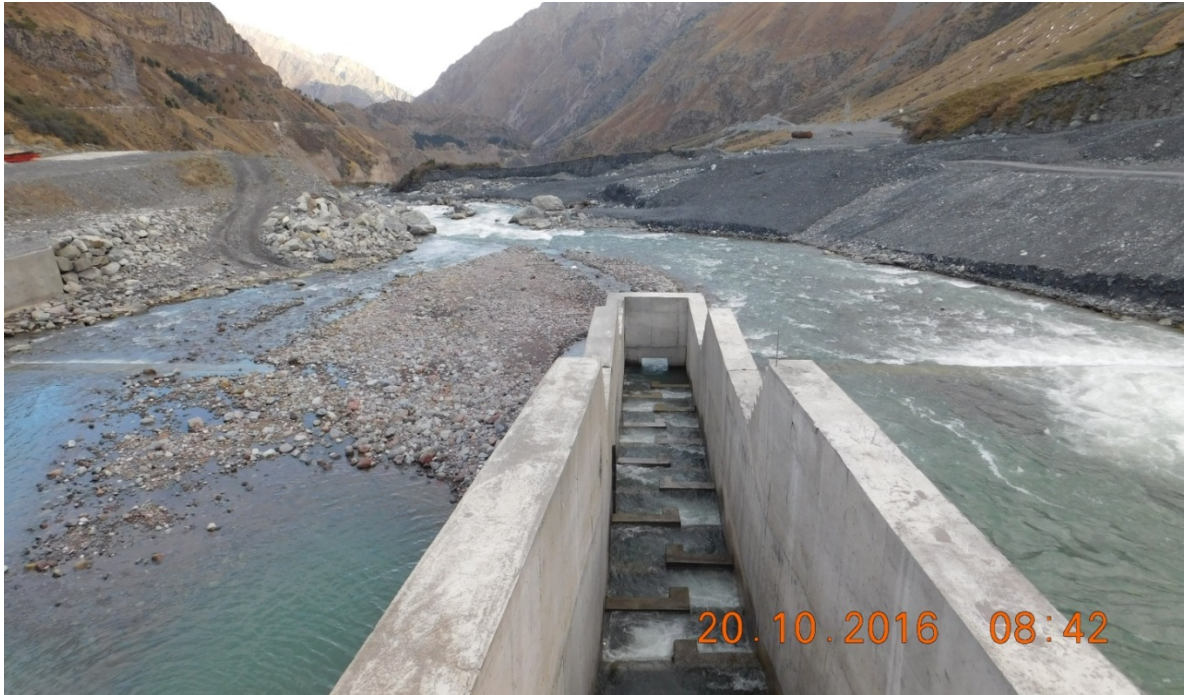
Figure 6. Tergi downstream the dam

In the same time, as far as the HPP was not commenced, most of water was passing through opened sluices directly to lower reach, creating distracting flow for the fish comparing to the flow in the fish pass. Further, all the flows united in one. In such conditions, the chance that trout will choose the narrow flow is not big. Nevertheless, the Consultant saw the brown trout jumping through the fish pass. The rest of the flow was discharged directly behind the dike. Therefore, Tergi riverbed downstream the HPP was split into three flows: narrow, central from the fish pass and two wide ones at right and left from it (Figure 6).

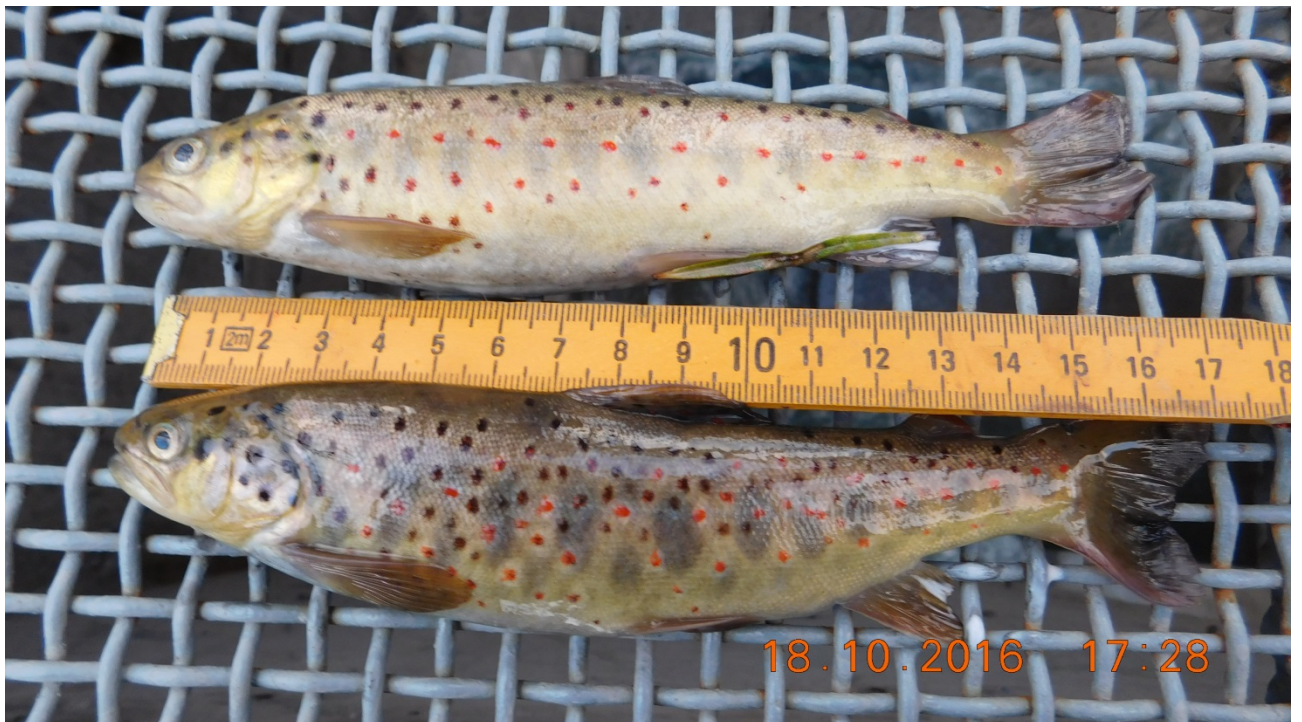
Figure 9. Trout caught in the fish pass

The Consultant caught two fish – both ready for spawning males of the length 15 cm (Figure 9).

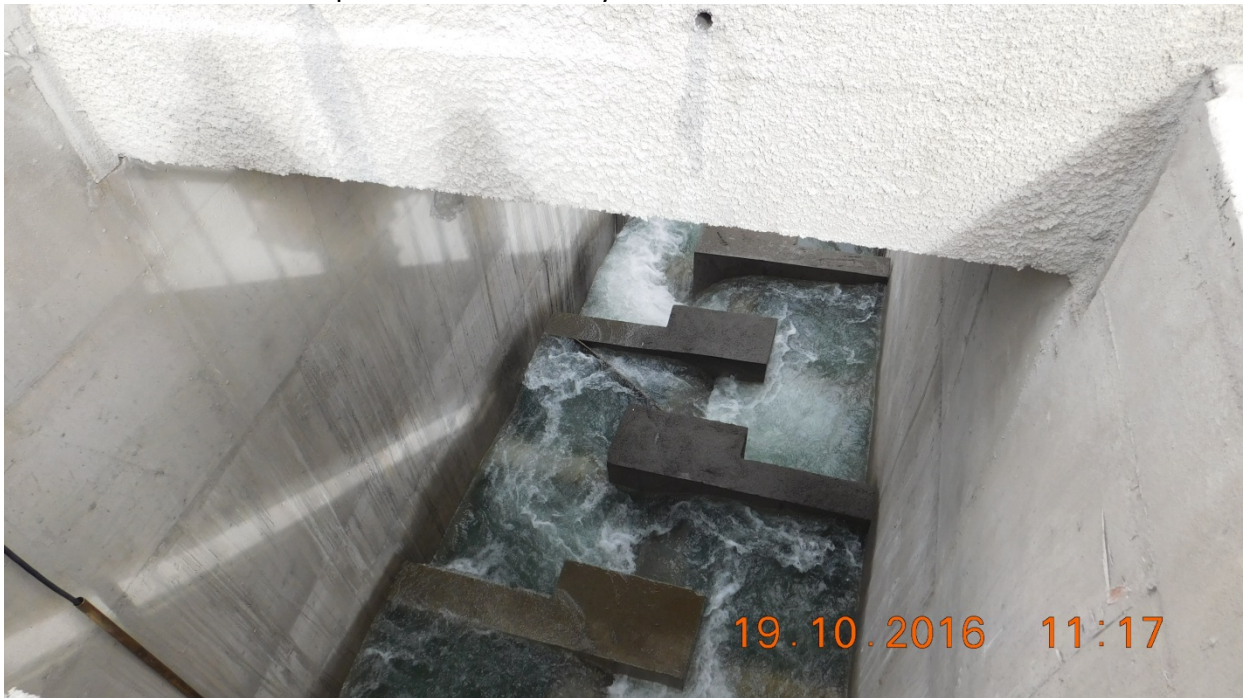
Figure 10. Wooden board closing the fish pass

2. Second placement during nighttime did not give any results. As it was found out later, there was a wooden board, which acted as a barrier in the fourth pool and did not allow fish passing. (Figure 10). This was later removed and that monitoring measures will be implemented to avoid this in the future (Mitigation measure 1E). The further monitoring of litter in the fish pass was confirmed by DE.

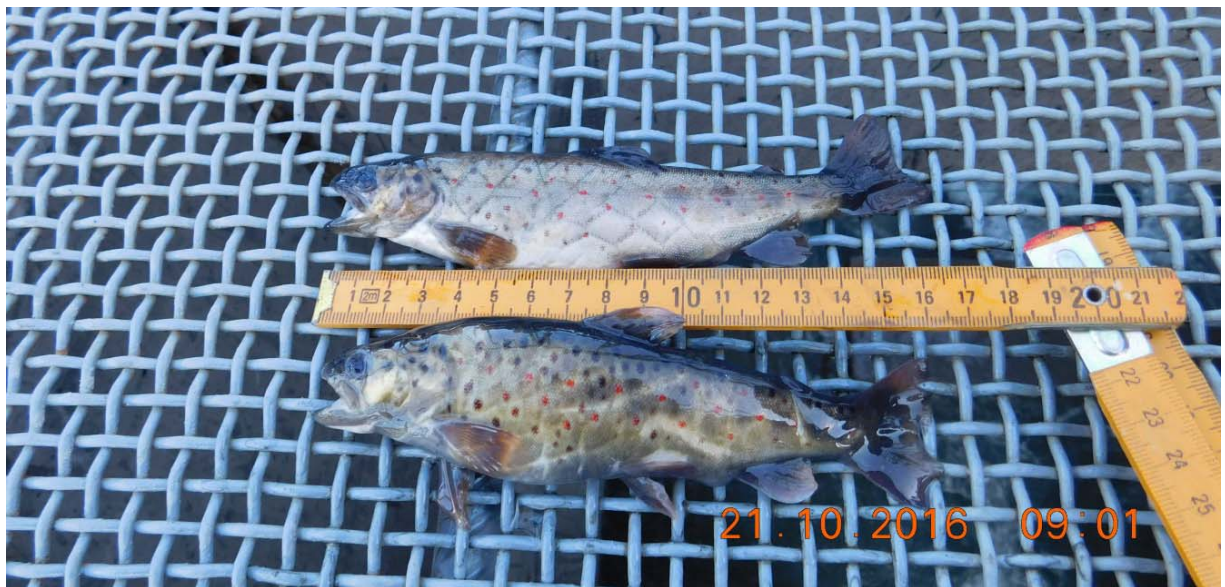
Figure 11. Dead female trout in the fish trap

3. Third placement for 24 hours led to catching of three males ready to spawn.
4. Fourth placement for 24 hours led to catchment of four fish out of which two males ready to spawn and two females. Both females were sub-pressed by flow to the fish trap and died because of hurting by stones, which the Consultant used as a loading for the fish trap (Figure 11).

- Even in conditions of opened sluices, when dominating flow distracts fish from entrance to the fish pass, trout easily finds it and enters the upper reach, which proved its efficiency.
- Water in water reservoir and in the fish pass in the autumn period is transparent, which allows for video control of the fish passing.
- The fish trap proved to be efficient, although there should be constructive amendments to the fish trap made to prevent the death of female trout as well as other technical adjustments.

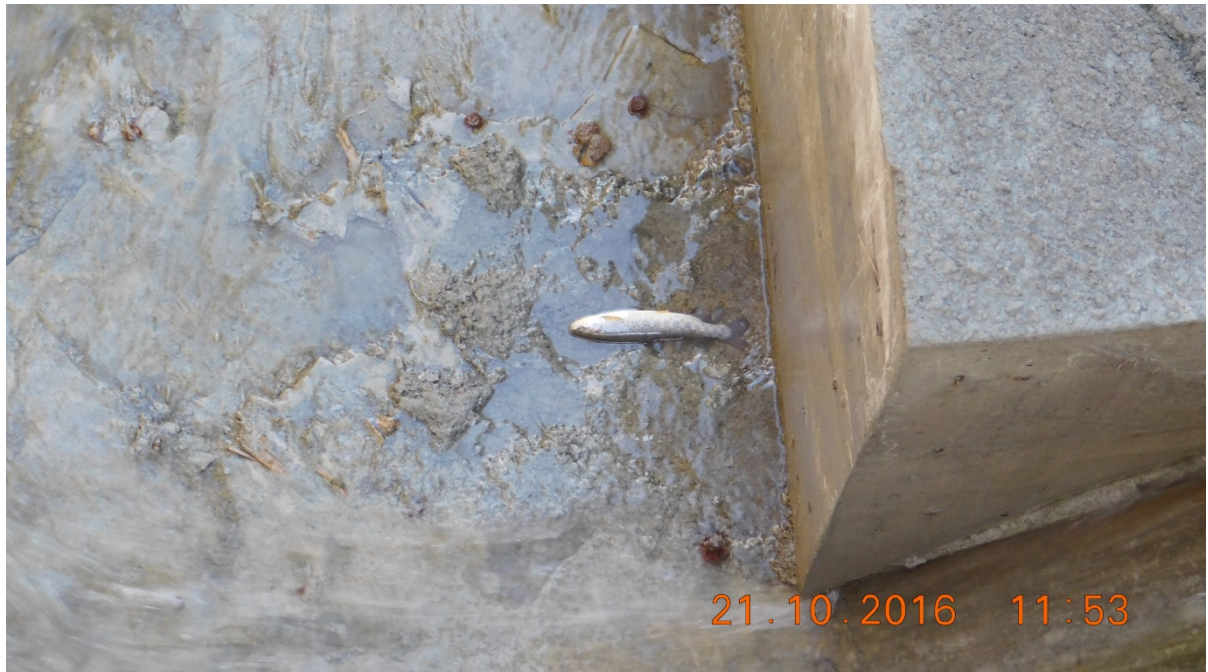
Figure 12. Trout at the temporary dried step of the fish pass (checking the efficiency of the fish pass)

During the first survey in the morning (low sun and lateral illumination) there were three trout specimen fixed – one in upper pool, and two in the second from bottom pool. During the second survey in the day light, when sun was high and there was a lot of light, glaring surface of water did not allow assessing of the fish present in the pools. However, during the drying out there was one large trout fixed in the second from top pool, which later jumped to the third from top pool (Figure 12).

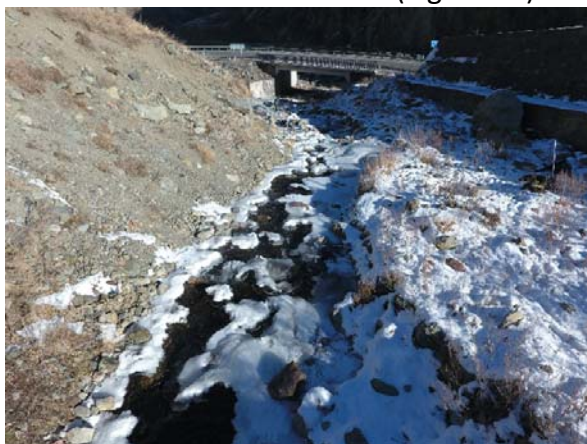
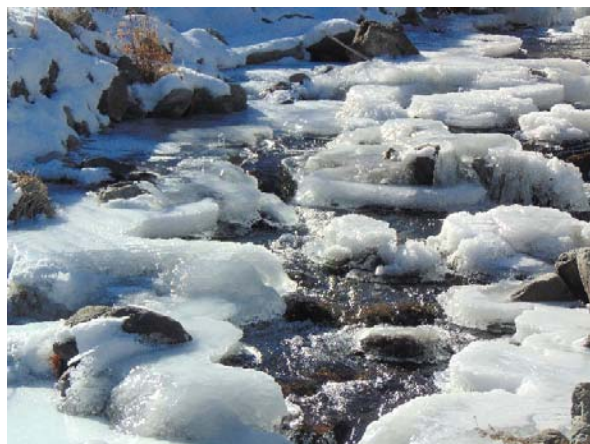
Figure 13. Ice at Tibaitskali

During the survey, weather conditions varied not significantly: sunny, the air temperature varied from +10 to -20 °C. According to the meteorological station Stepantsminda, the average monthly temperature in November is -2.6 °C¹. Snow that fell earlier (about 100 – 120 mm) created difficulties for access to the river and proper assessment of the riparian zone. Tibaitskali river channel in its mouth was cover by ice in many places, which created some difficulties for measurements (Figure 13).

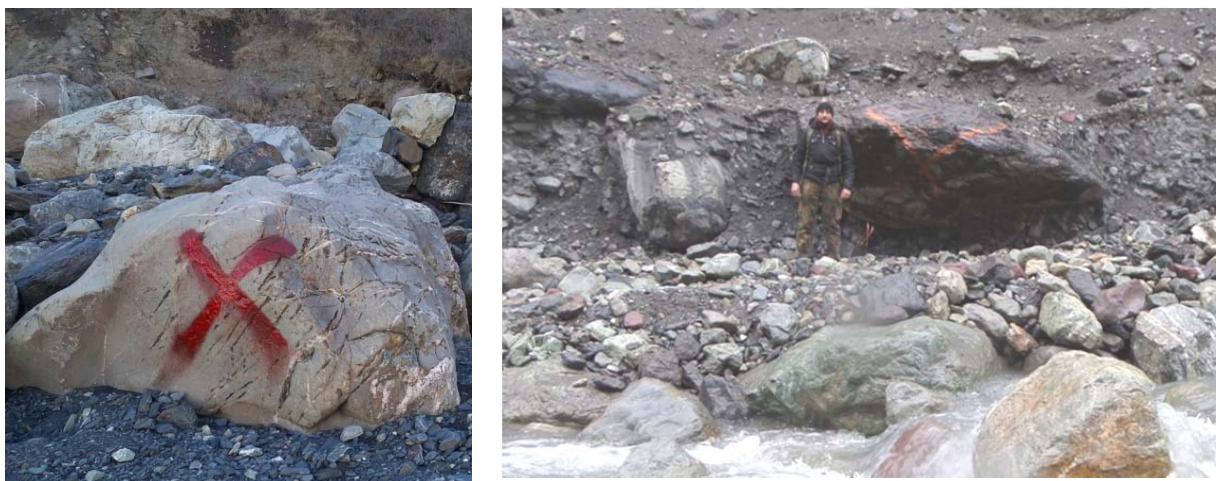
Figure 14. Marking of the monitoring station (March, 2015)

During 2016, the borders of each monitoring station were fixed using GPS monitoring, as well as by colour marks at boulders or concrete walls (Figure 14) in order to return to the same monitoring stations during the post-commissioning monitoring 2016. Unfortunately, colour marks were washed away during high water season (Tergi boulder section station M2 and Tibaitskali mouth station M11) so GPS coordinates were used for finding exact location of stations.

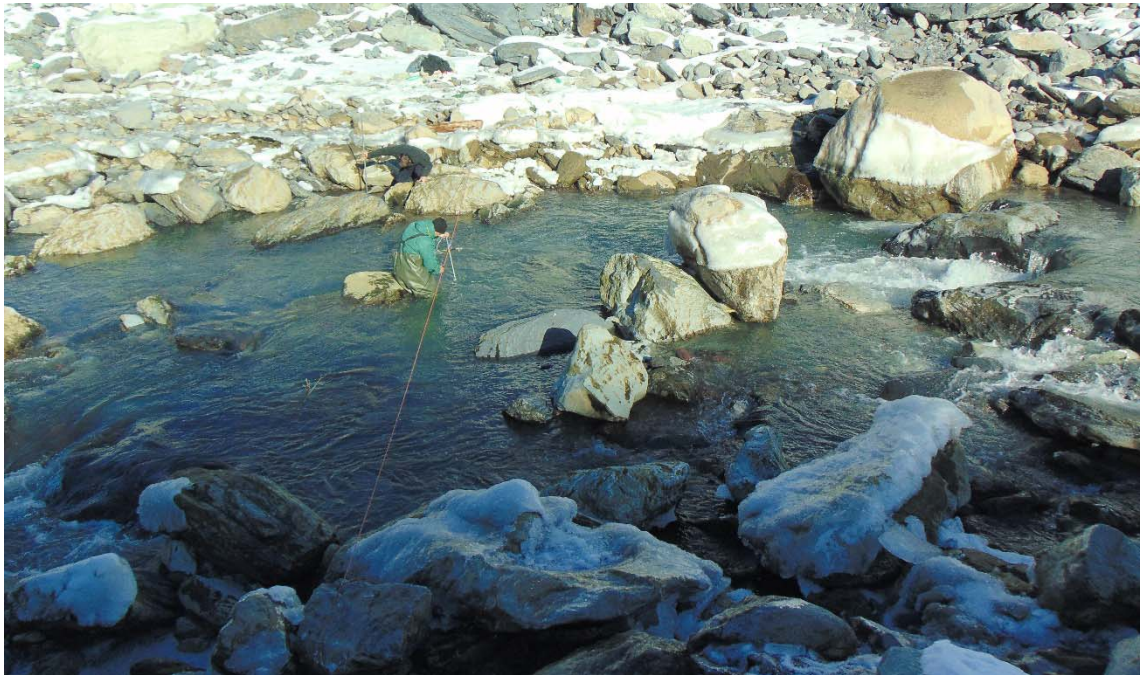
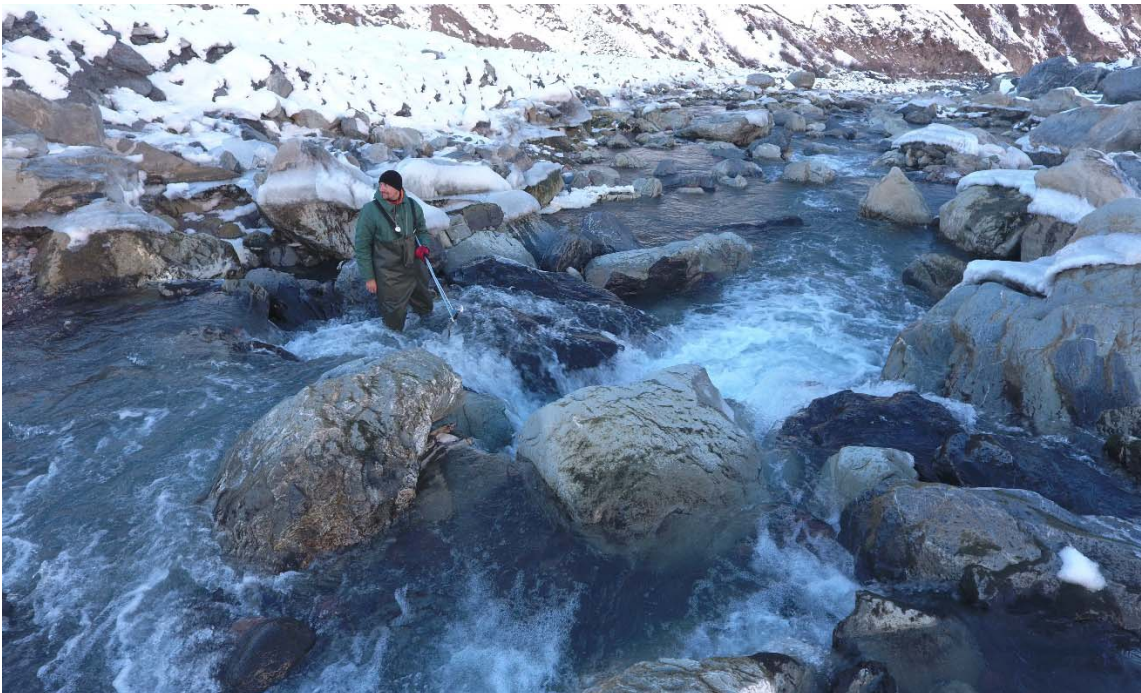
Figure 15. Tergi downstream the Dariali headwork (boulders section)

The average velocity was 0.54 m/s with maximum 2.0 m/s. Flow types included chute, chaotic, broken standing waves, and unbroken standing waves (Figure 15).

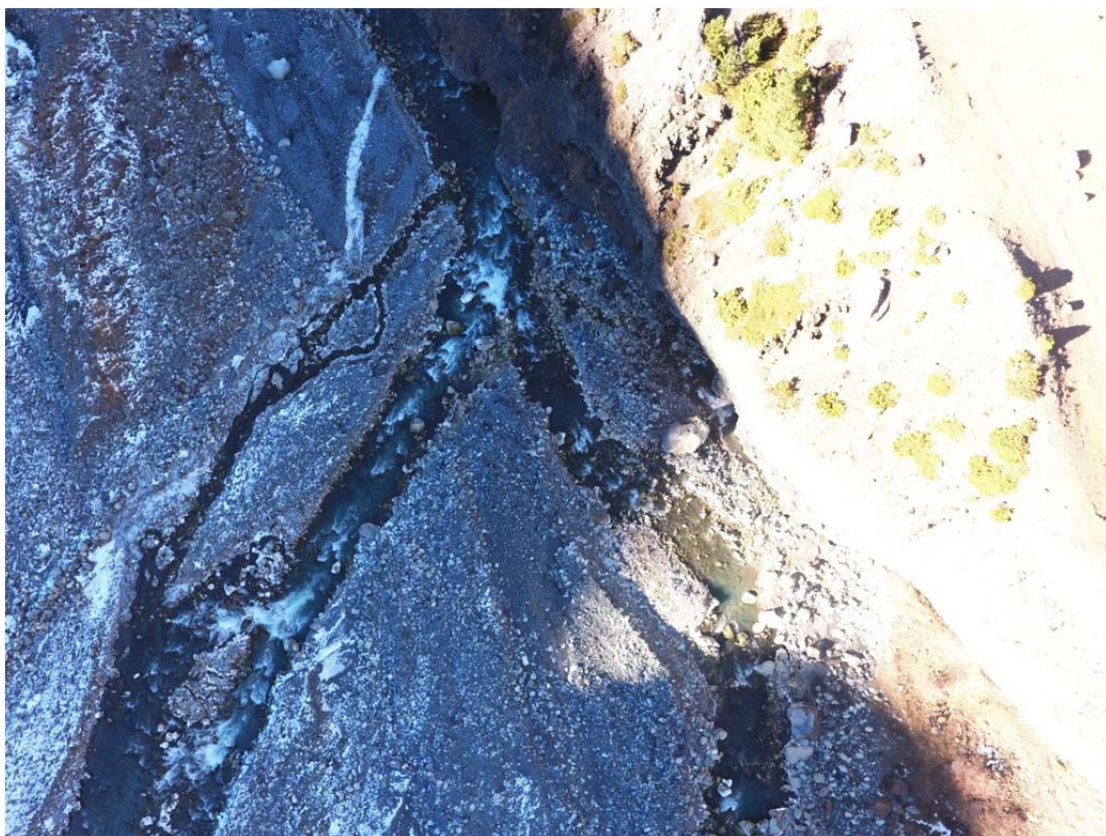
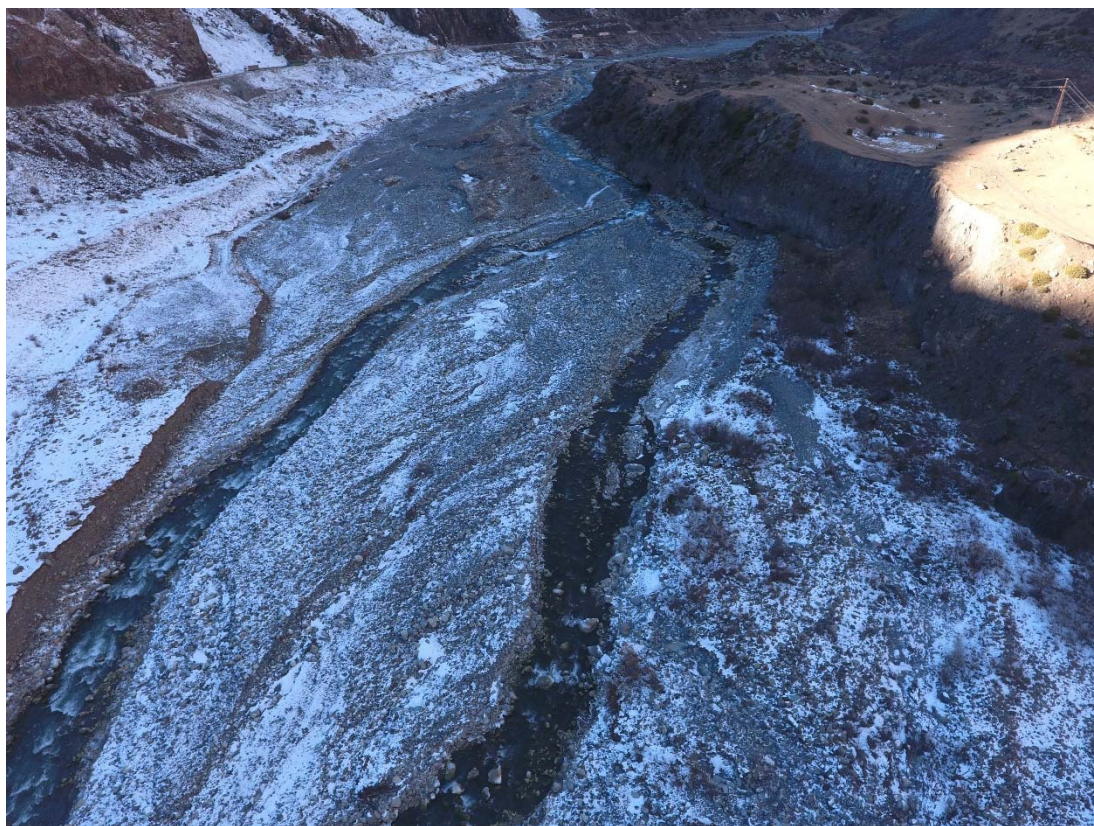
Figure 19. Tergi, downstream the Dariali headwork (braided section)

The average velocity was 0.64 m/s with maximum 1.85 m/s. Flow types included chute, chaotic, broken standing waves, and unbroken standing waves (Figure 20). The average width of the right arm was 4.8 m with maximum 5.2 m and the average width of the left arm was 10.8 m with maximum 15.3 m. Bed elements included island, riffles, and pools.

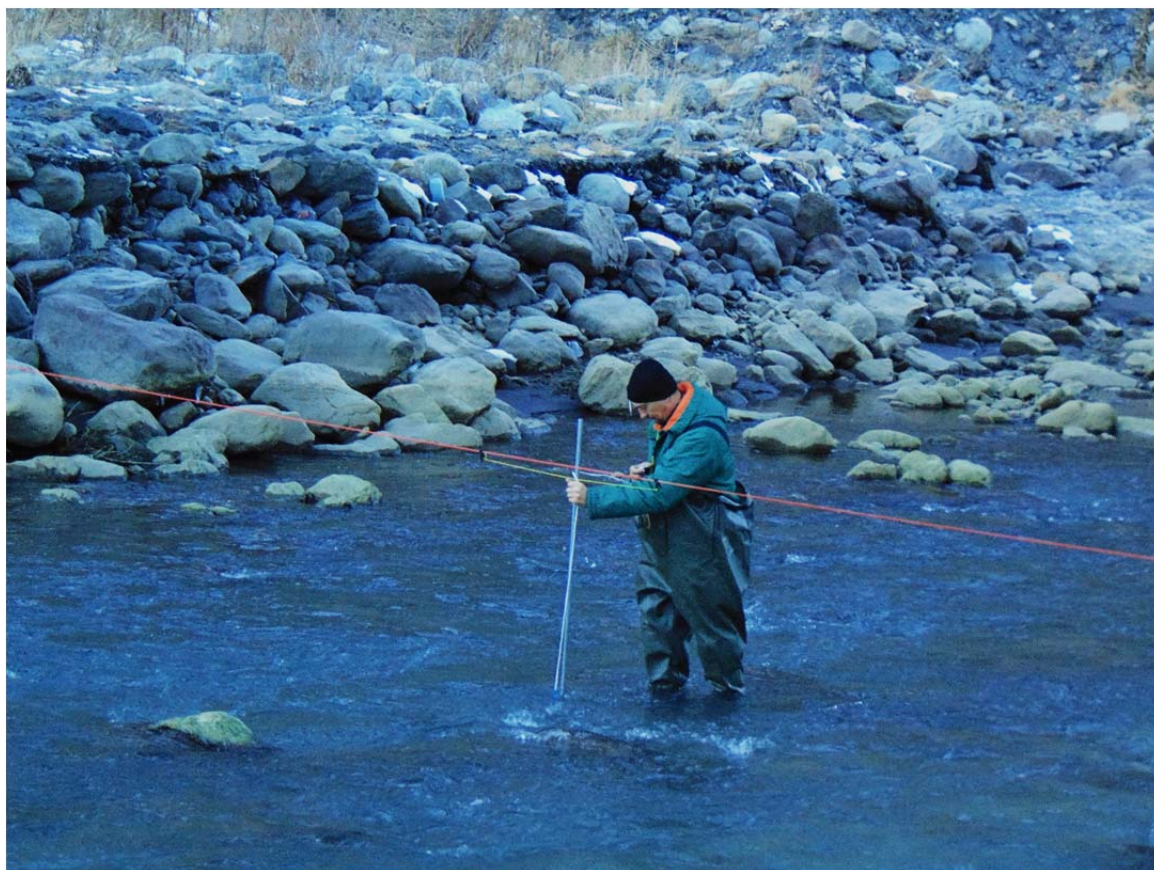
Figure 23. Tergi downstream the Dariali headworks (single thread section)

The average velocity was 0.58 m/s with maximum 2.0 m/s. Flow types included chute, chaotic, broken standing waves, and unbroken standing waves. The average width of the river was 12.9 m with maximum 14.5 m. Bed elements included rapids, riffles and pools (Figure 24).

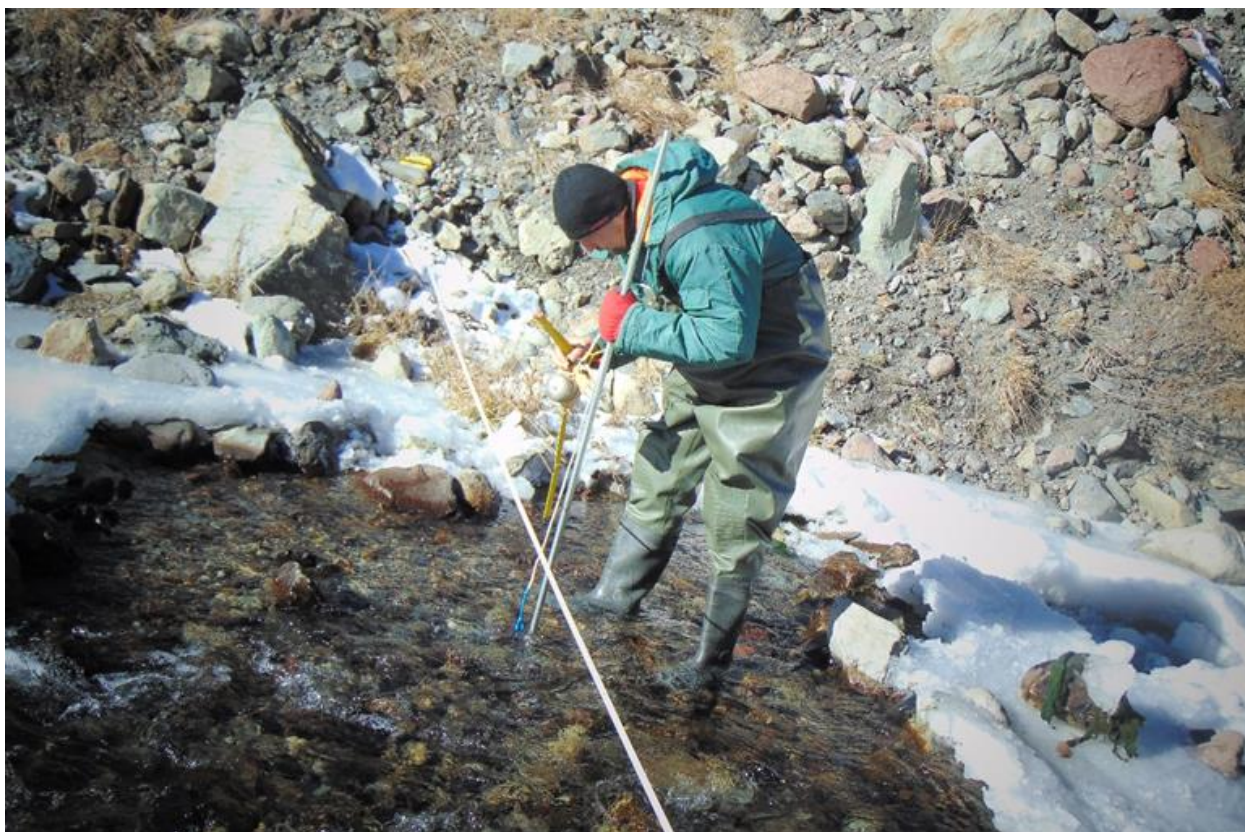
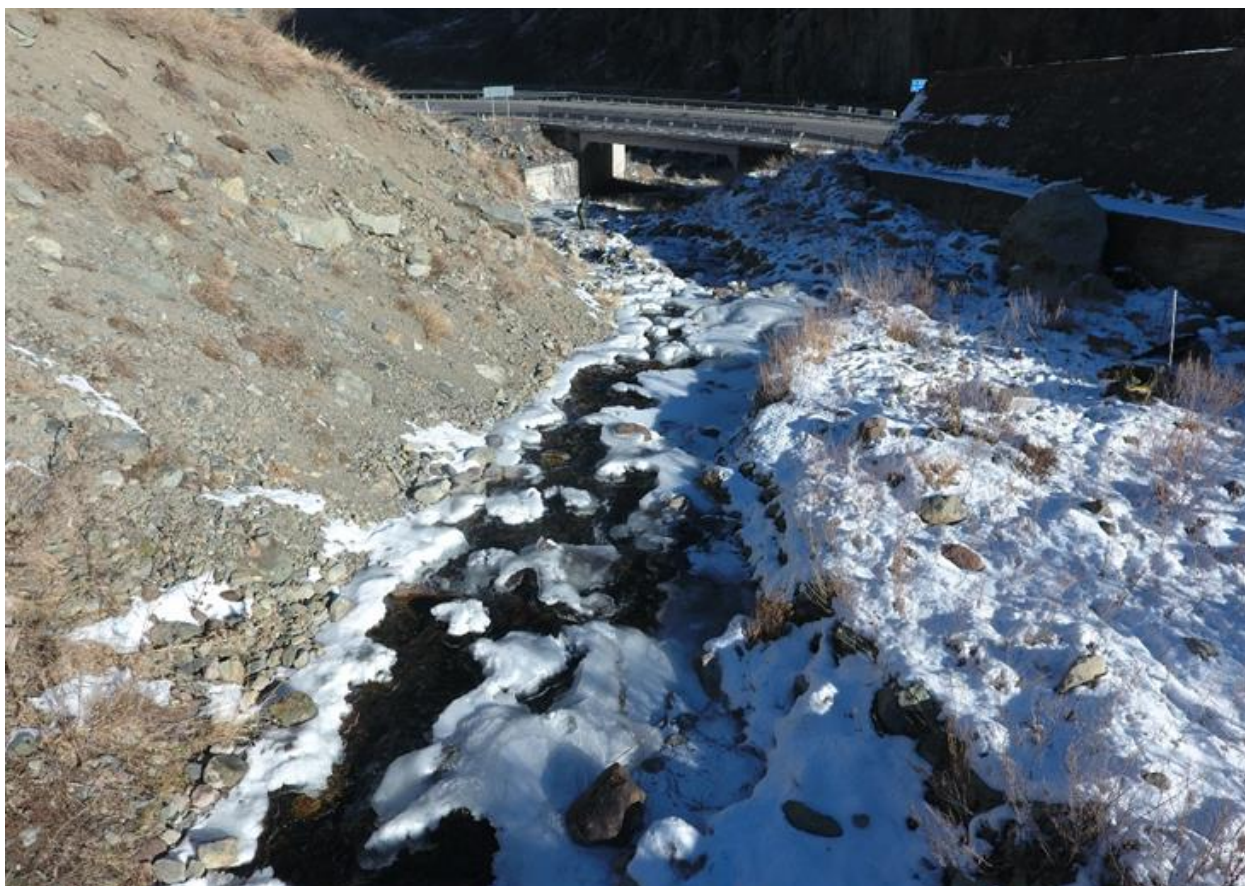
Figure 27. Tibaitskali mouth

The average velocity was 0.44 m/s with maximum 1.2 m/s. Flow types included chute, chaotic, broken standing waves, and unbroken standing waves (Figure 28). The average width of the river (not covered by ice) was 1.2 m with maximum 2.16 m. Bed elements included rapids, riffles and pools.

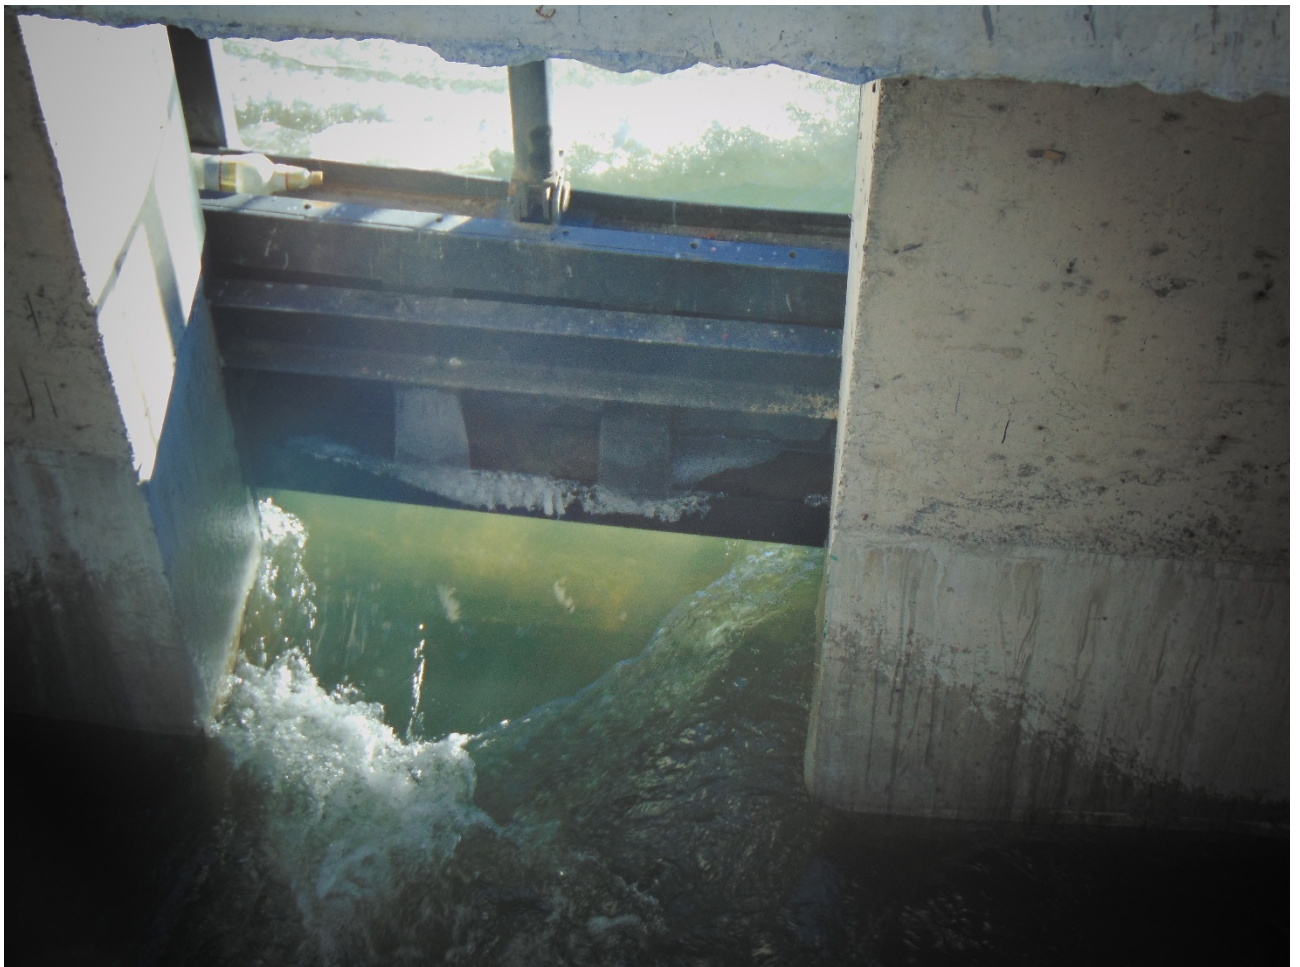
Figure 31. Sluice at the fish pass

Hydrological survey of the fish pass included the measurements of water levels and flow velocity in the fish pass sluice. The goal was to assess if the fish pass has critical for brown trout zones in it depending of water level at threshold of the sluice.

Methodology included visual assessment of the fish pass zones and calculation of maximum flow velocities and minimal water depths in conditions of different water levels at threshold of the sluice of the fish pass (Figure 31).

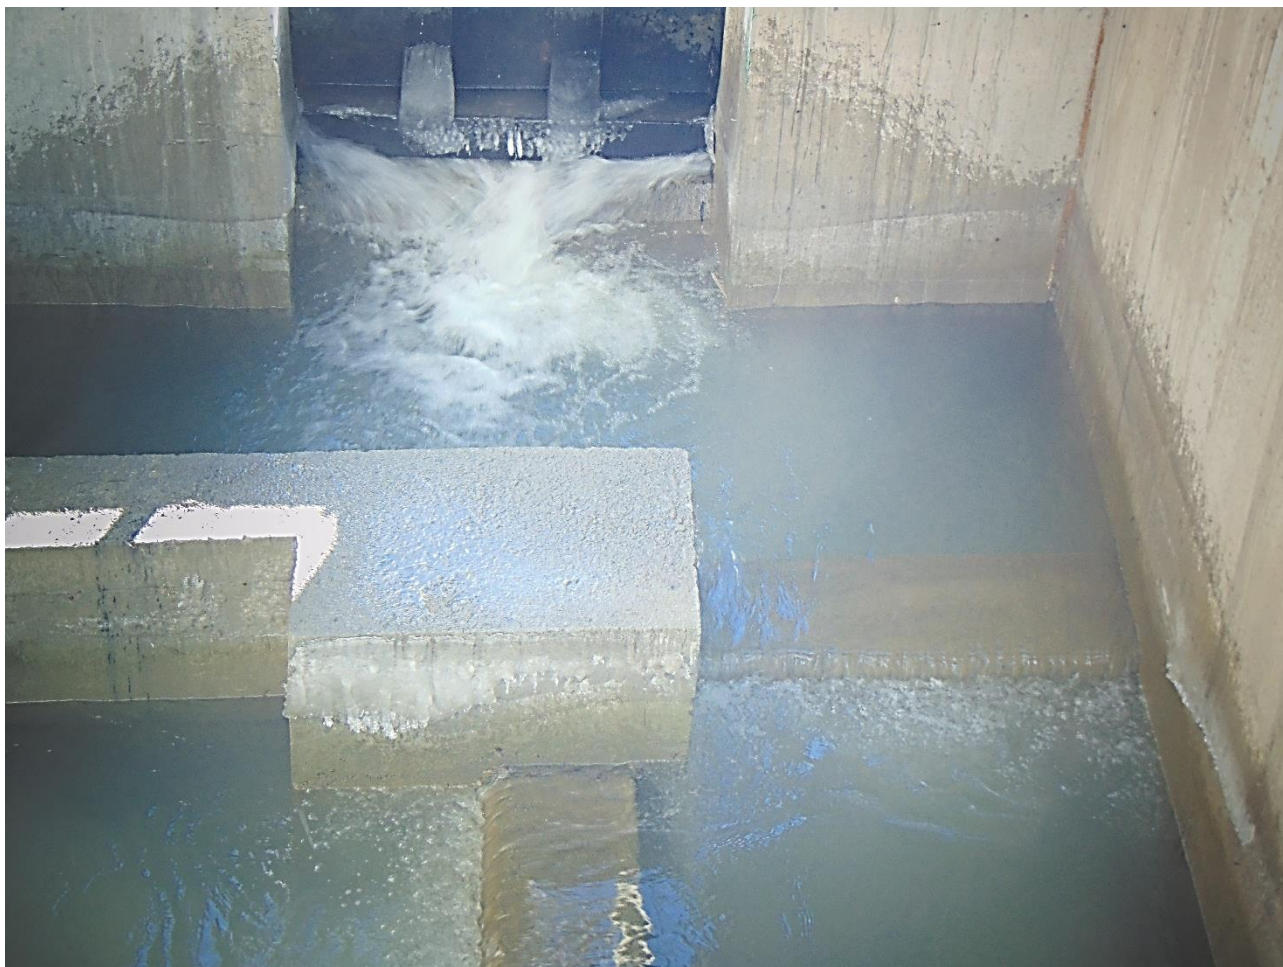
Figure 32. Water leaking during the full closure of the fish pass

The fish pass was clean from sediments and construction waste. In some places, the fish pass bottom and walls were covered by up to 3 cm of ice. When fish pass is closed, some water leaking in the lower reach was observed because of ice at the edges of sluice and its bottom (threshold) (Figure 32).

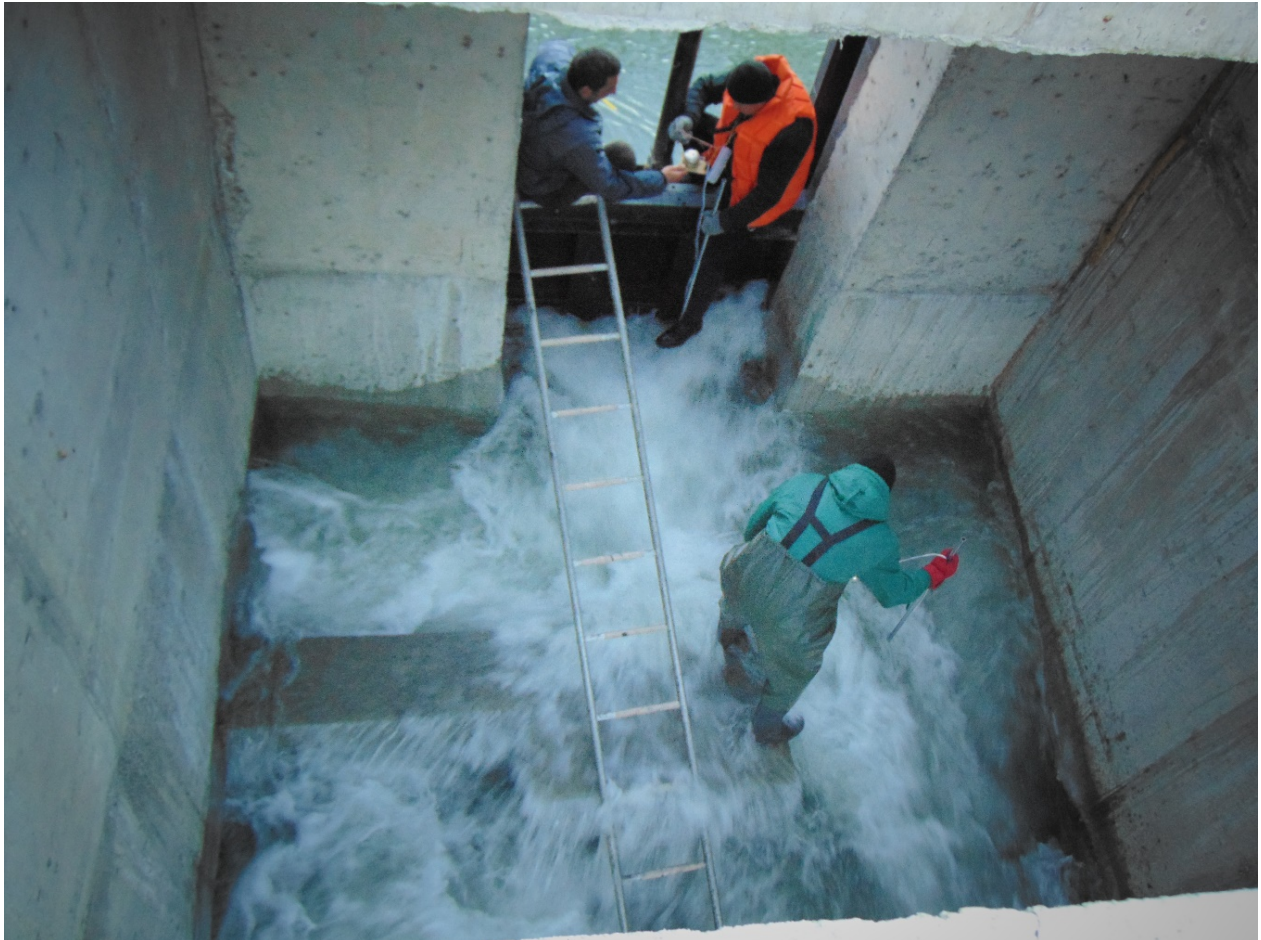
Figure 33. Fish pass calibration

1. Assessment of the fish pass to identify the critical zones in terms of depths and velocity;
2. Measurements of water depths, flow velocities and water discharges at threshold of the sluice;
3. Checking the accuracy of the installed automatic meters of water level and discharge.

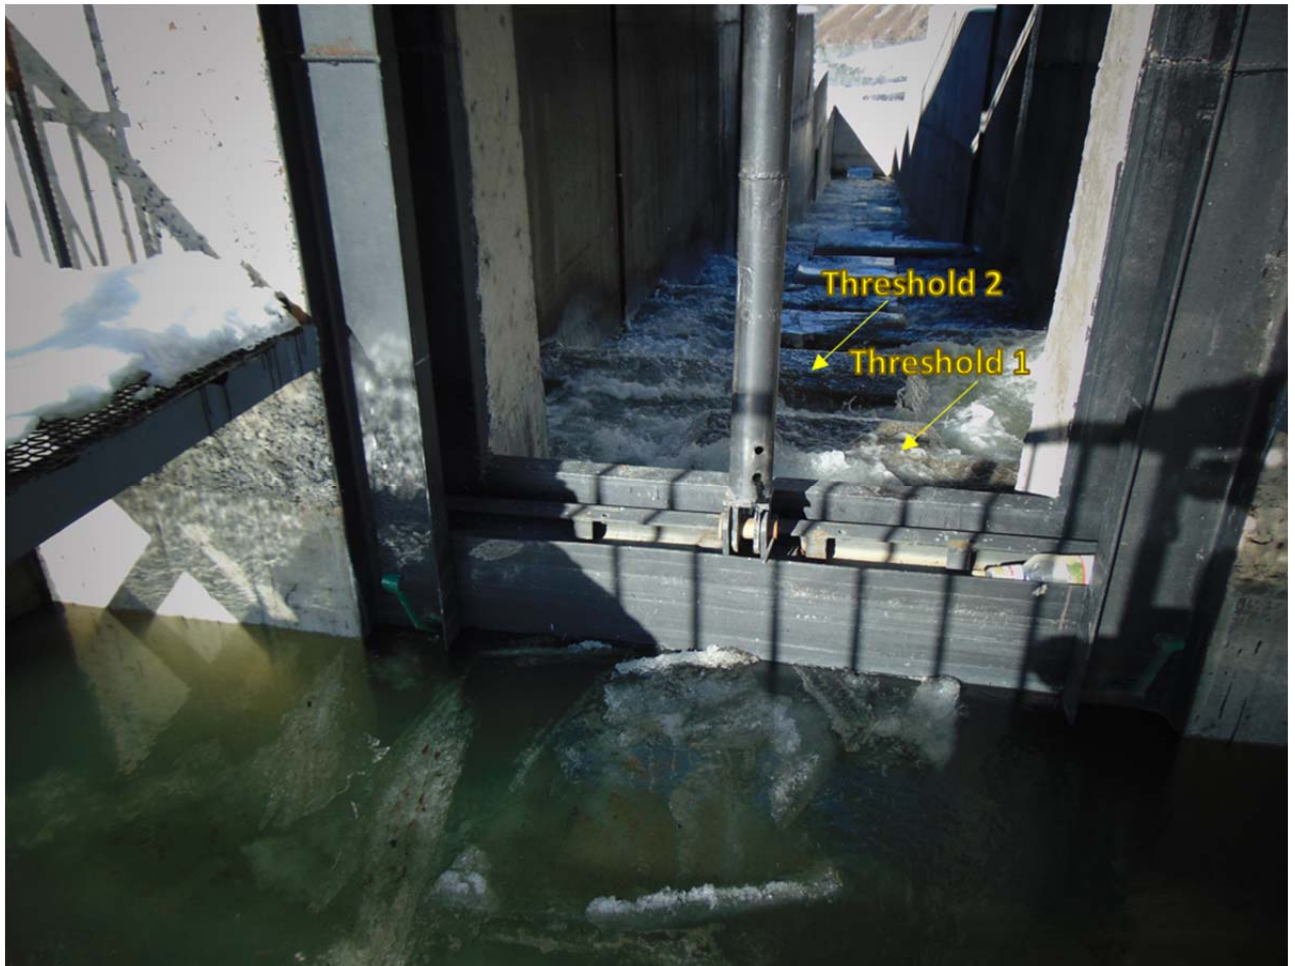
Figure 34. Thresholds, where depths and velocities were measured

During the above-mentioned period, there were 54 measurements done (22 at the sluice of the fish pass, 37 measurements at thresholds №1 and №2 from the sluice (Figure 34). The relevant data are present in Tables 4-7 and at Figures 34-36.

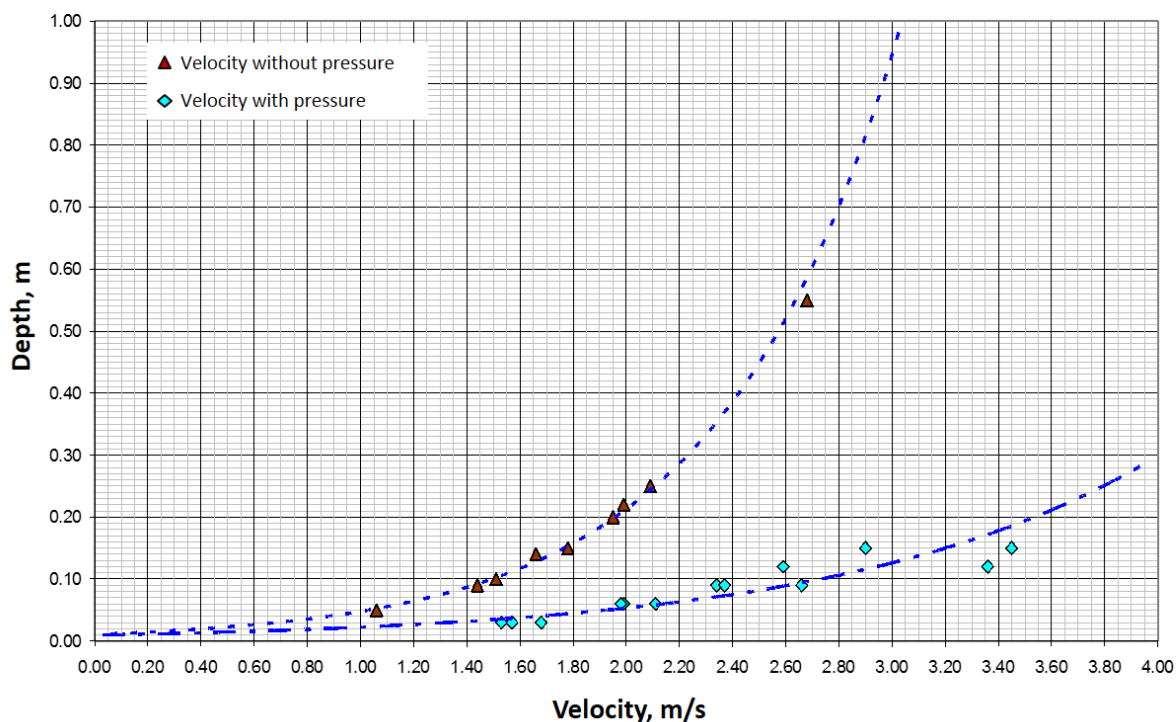
Figure 35. Chart of dependency of flow velocity and water depth at the threshold of sluice of the fish pass or height of the sluice opening (with pressure and without)³.

There was primary overflow of the water through the partition of the fish pass. It can be observed at the threshold of the fish pass above 28 cm. Flow velocity along the length of the fish pass, except the threshold of sluice of the fish pass was distributed quite equally and was not more than 1.6 m/s in conditions of depths variation at the sluice threshold up to 30 cm. Detailed correlation between water depths and flow velocity (with / without pressure) is given at Figure 35.

³ Flow velocity under pressure were measured at the water level in upper reach of water reservoir at the range of 1734.53-1734.80)

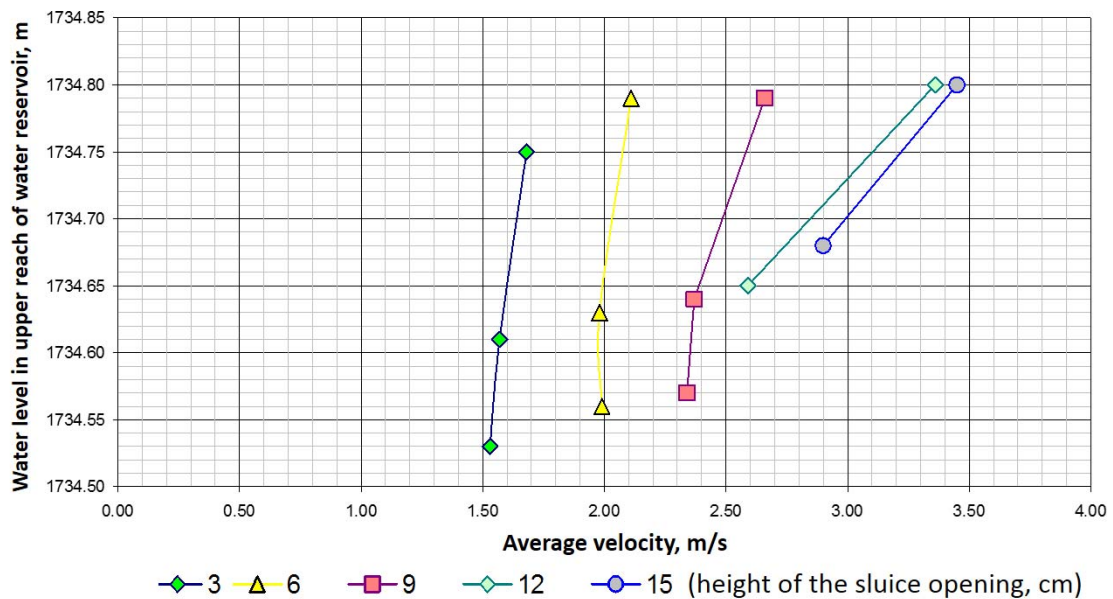
Figure 38. Dependency of the flow velocity under pressure on the height of the opened sluice and water level in upper reach of the water reservoir

Under pressure and opened sluice by 25 cm and more, the measured flow velocity at the sluice is 2.2 m/s and more, which is critical for successful leaving by the brown trout of the fish pass because optimal velocity for the brown trout is in range of 0.8 -1.5 m/s. The comfortable conditions for the fish correspond to the opened sluice of the water reservoir between 3 and 25 cm (Figures 38, 39 and 40). In general, the fish pass sluice is the most critical place in the fish pass for the free moving of the fish from lower reach to upper reach of Dariali HPP.
