Project “Development and Implementation of Aquatic Biodiversity Action Plan for Dariali HPP”

Aquatic biodiversity: monitoring results in 2016 and mitigation measures proposed

Report

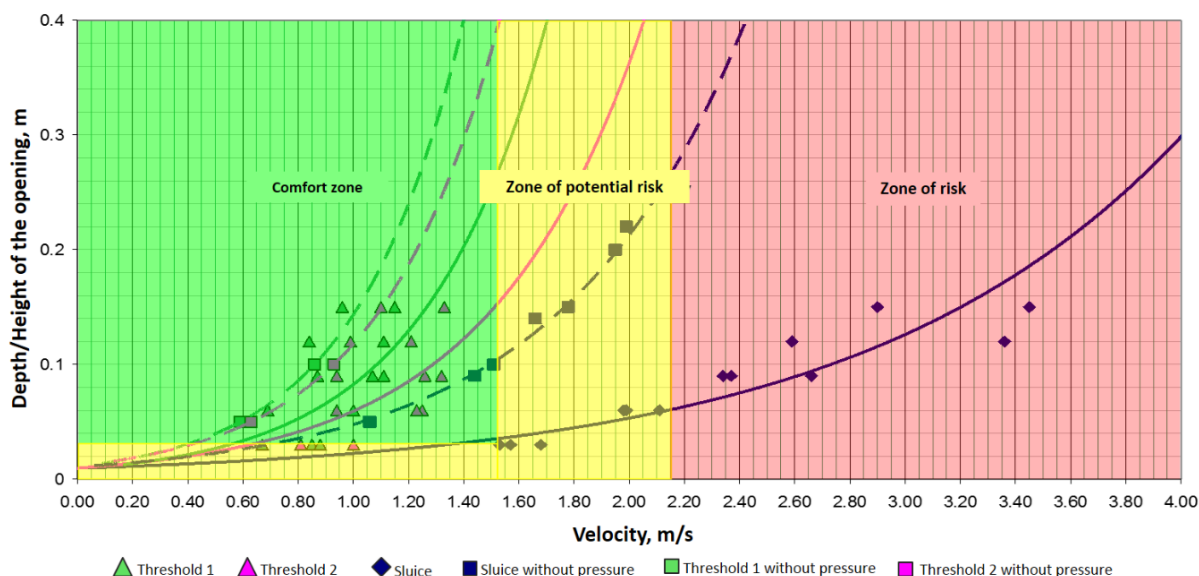
Figure 39. Chart of dependency of flow velocity at thresholds #1, #2 and sluice of the fish pass on water depth at the threshold of sluice / height of the opened sluice with / without pressure as well as zones of comfort for brown trout

Assessment of the features of the flow of the fish pass confirmed that there is homogeneity of flow velocity and water level regime along the whole length of the fish pass. Based on the surveys data on the thresholds №1 and №2 of fish pass, there are no critical for the fish velocities in the measured framework fixed.

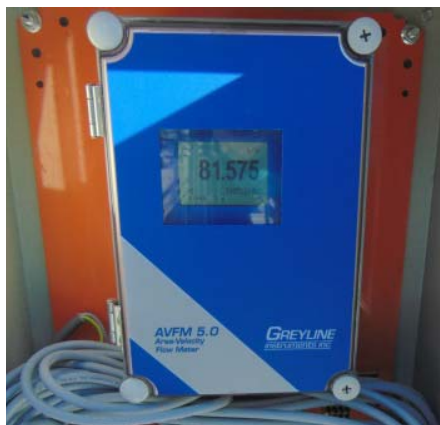
Figure 42. Maximum value showed at AVFM 5.0 during the surveys

Automatic device measuring the water discharge in the fish pass (AVFM 5.0 Area Velocity Flow Meter) is not calibrated to show the real discharges. The data of the automatic device varied between 0.15 l/s and 81.6 l/s (Figure 42) when measured data varied between 120 l/s and 640.0 l/s.

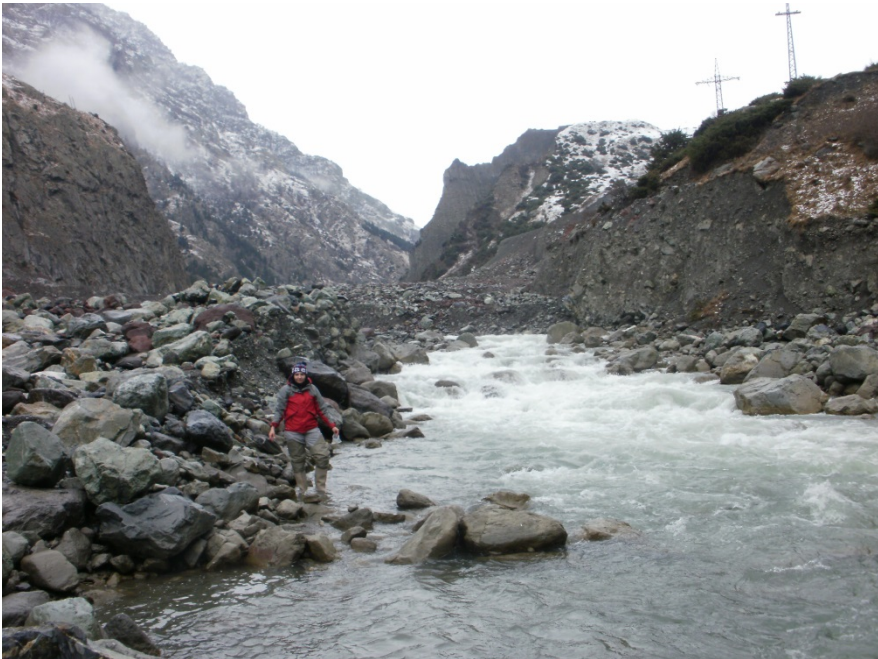
Name of the water body	Monitoring station 2
<p>Tergi downstream the Dariali headworks (boulder section)</p>

<p>Downstream the dam of Dariali HPP</p> <p><u>Coordinates:</u> N – 42°40'06,7" E – 44°38'32,5" H – 1693 m</p>
Date 2015-03-29; 04; 11-01	Weather: sunny +4 – + 26
