Construction of Dariali HEPP

Reinstatement Plan

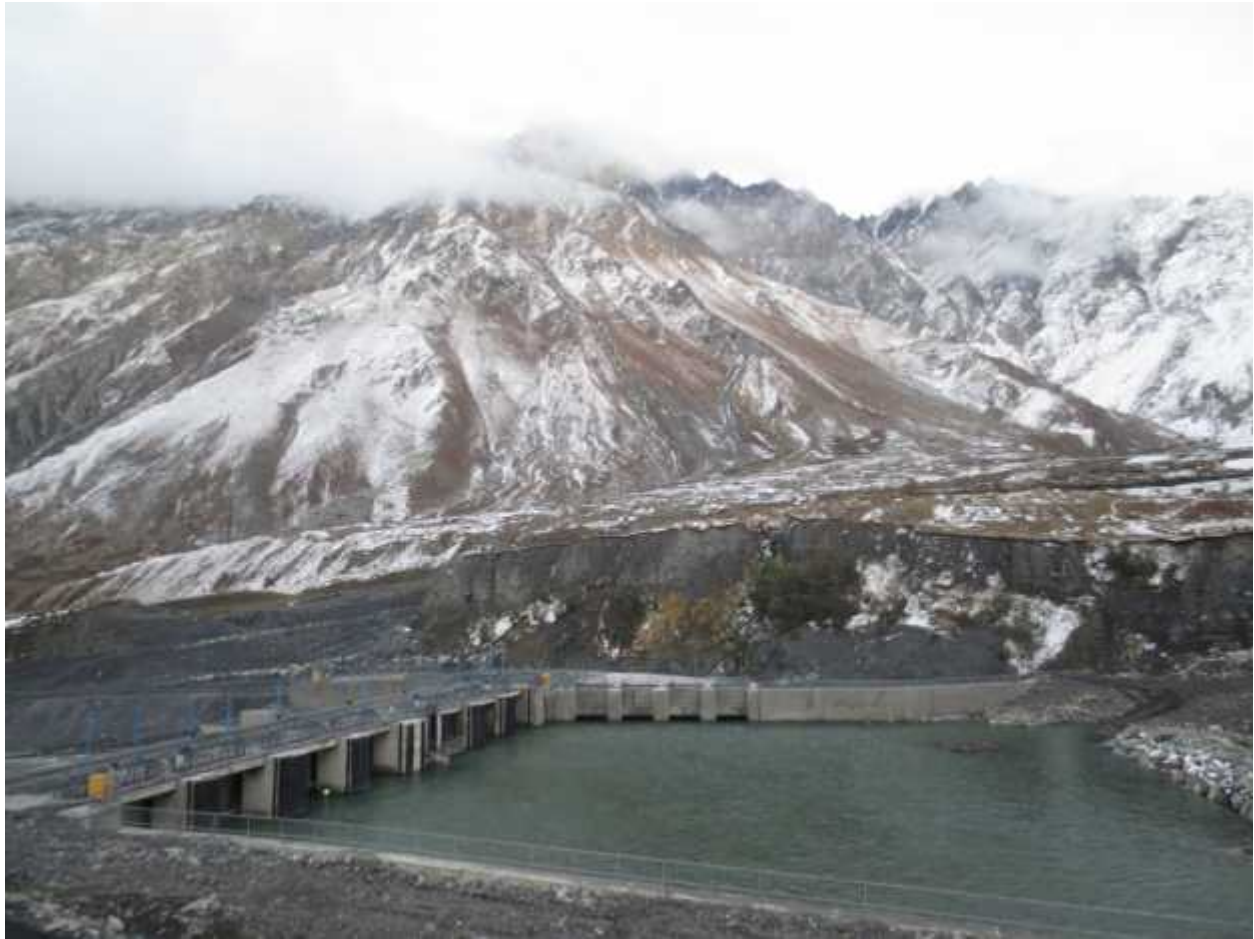
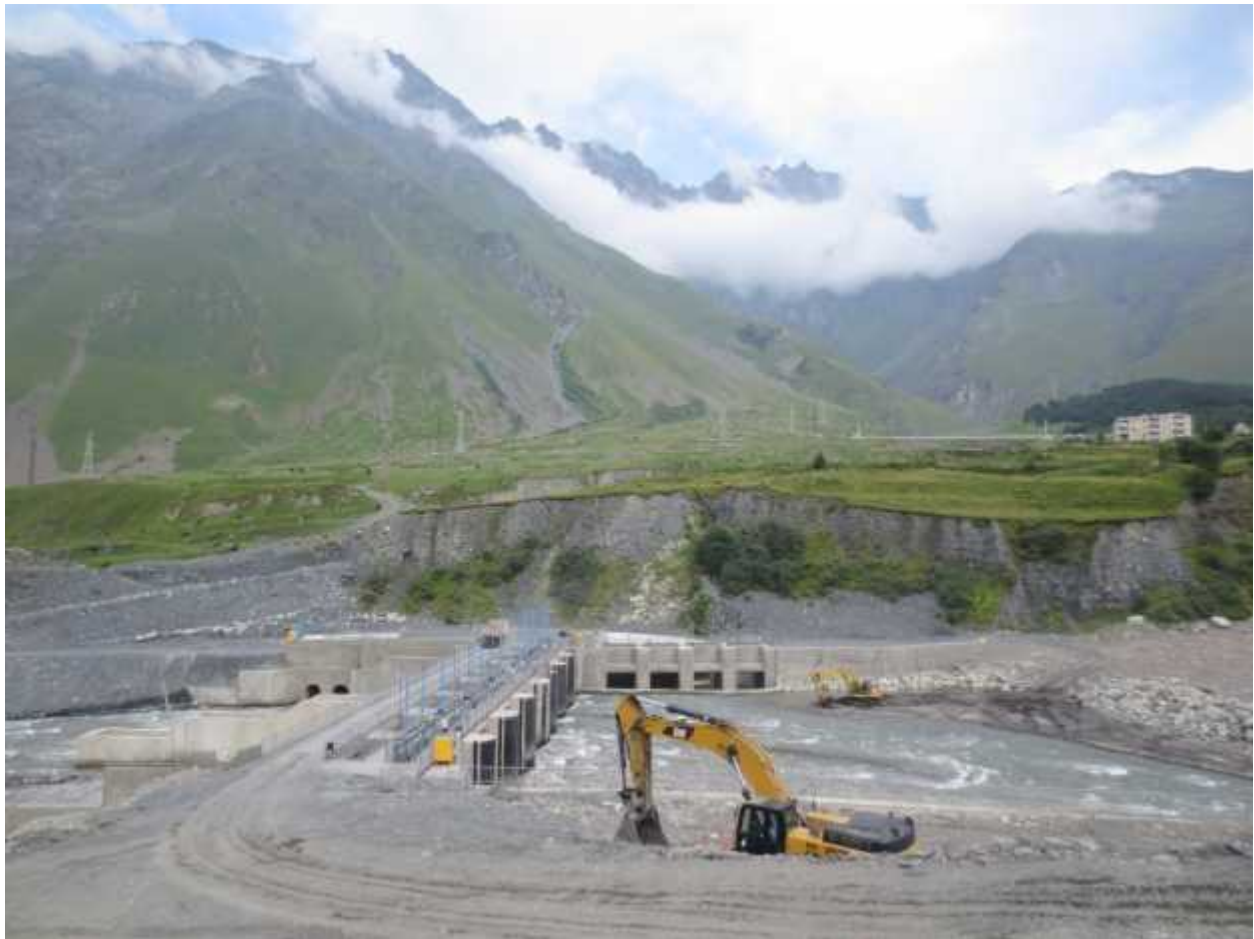
Leveling and grading activities should be carried out at the rebar and pipes storage area. Accumulated excavated material to be spread and level so, that the contours blend into the surrounding to the extent feasible. Photo below shows rebar storage area.

The rebar and pipe storage area was cleared from temporary facilities. Leveling and grading activities have been started.

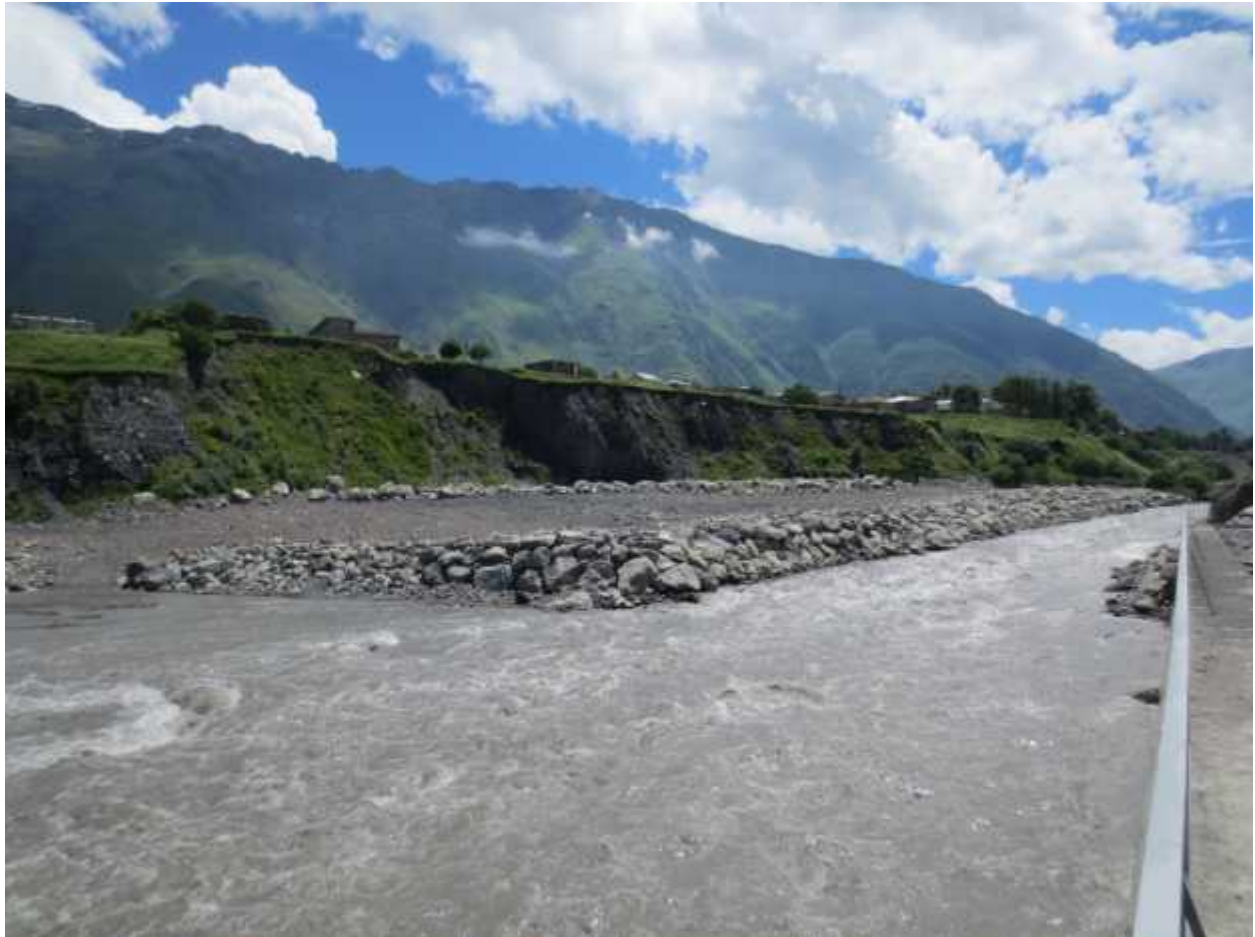
Reinstatement of Tergi riverbank was carried out: Excavated materials accumulated alongside to river and also used for river diverting for dam construction was removed and used for leveling and grading and also for stabilization bottom of the adjacent slope. The river was returned to its natural riverbed and the riverbanks were protected by riprap.

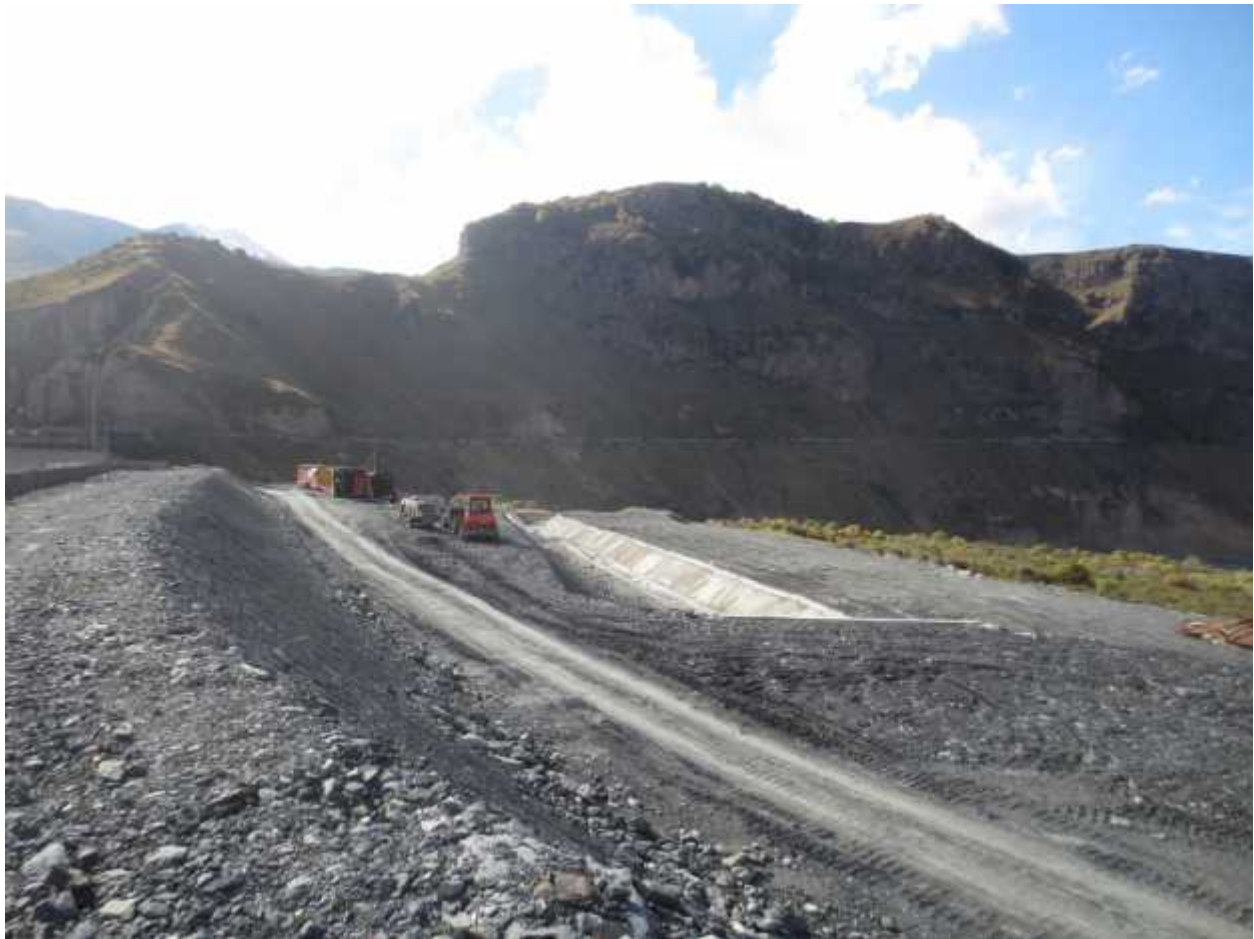
On more point of excavated materials storage has been observed during the site reinstatement survey, close to the headwork. Materials have been used as a layer for pipe temporary storage. Rocky soil has been spread on topsoil for pipe lying. This material should also be taken and re-used. Photos below shows rocky soil spread on topsoil.

No improvement has been observed yet. According contractor works will be carried out after dismantling temporary facilities next to the accumulated materials.

Major part of temporary facilities was dismantled;however, facilities are still to be removed from settling basin area. Contractor is planning activities after completing with headwork dam area.

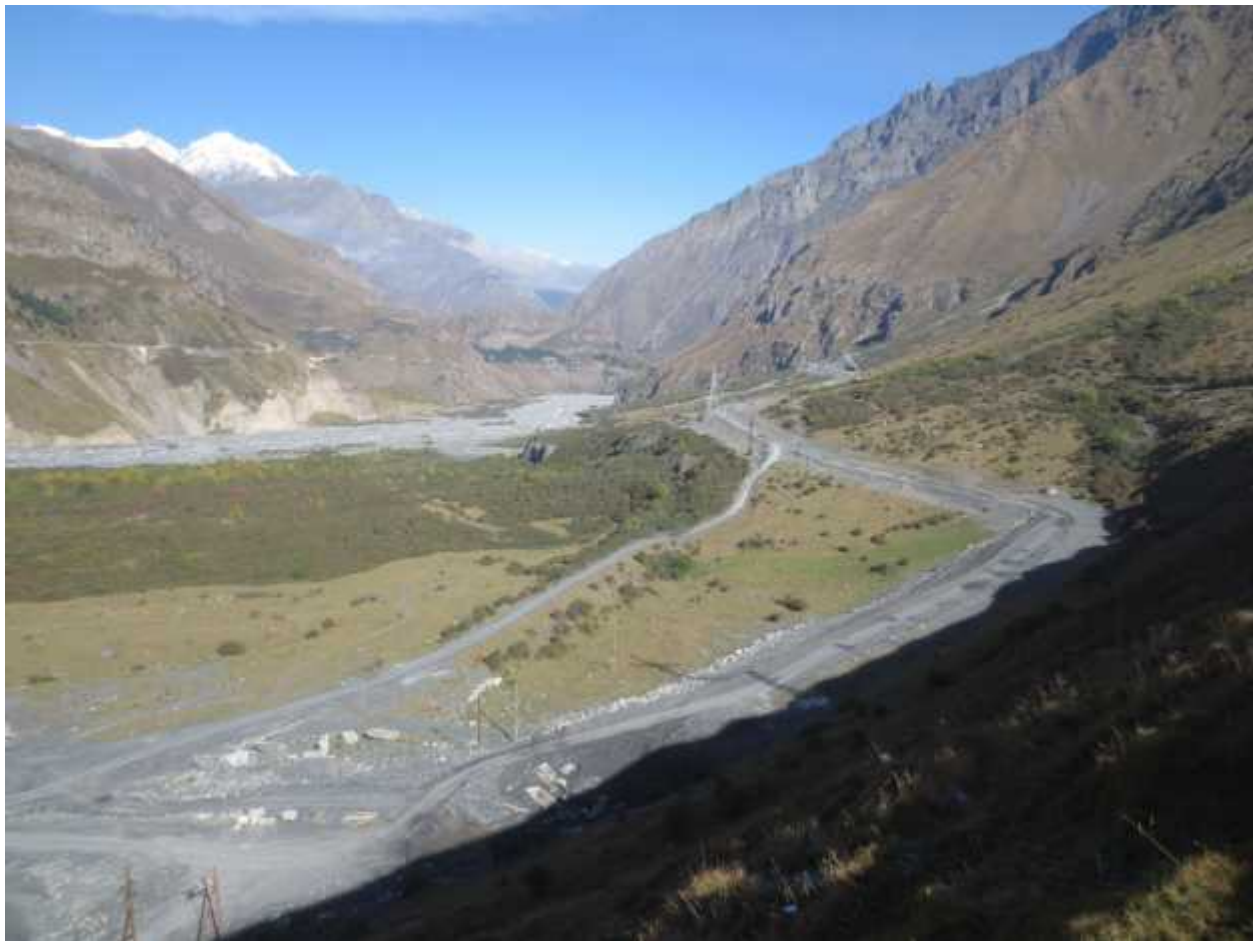
Photo below shows backfilled pipeline and slopes installed as extent feasible. This practice will be used at entire length of pipeline. Natural re-vegetation is considered to be sufficient to restore

Installation of the pipeline was completed: entire length was backfilled and the corridor reinstated as far as practicable. Natural re-vegetation was considered to be sufficient to restore the slopes cover. A slight vegetative cover is forming from the annual grass growing on the slopes above and a small annual grass species. Monitoring should be continued.

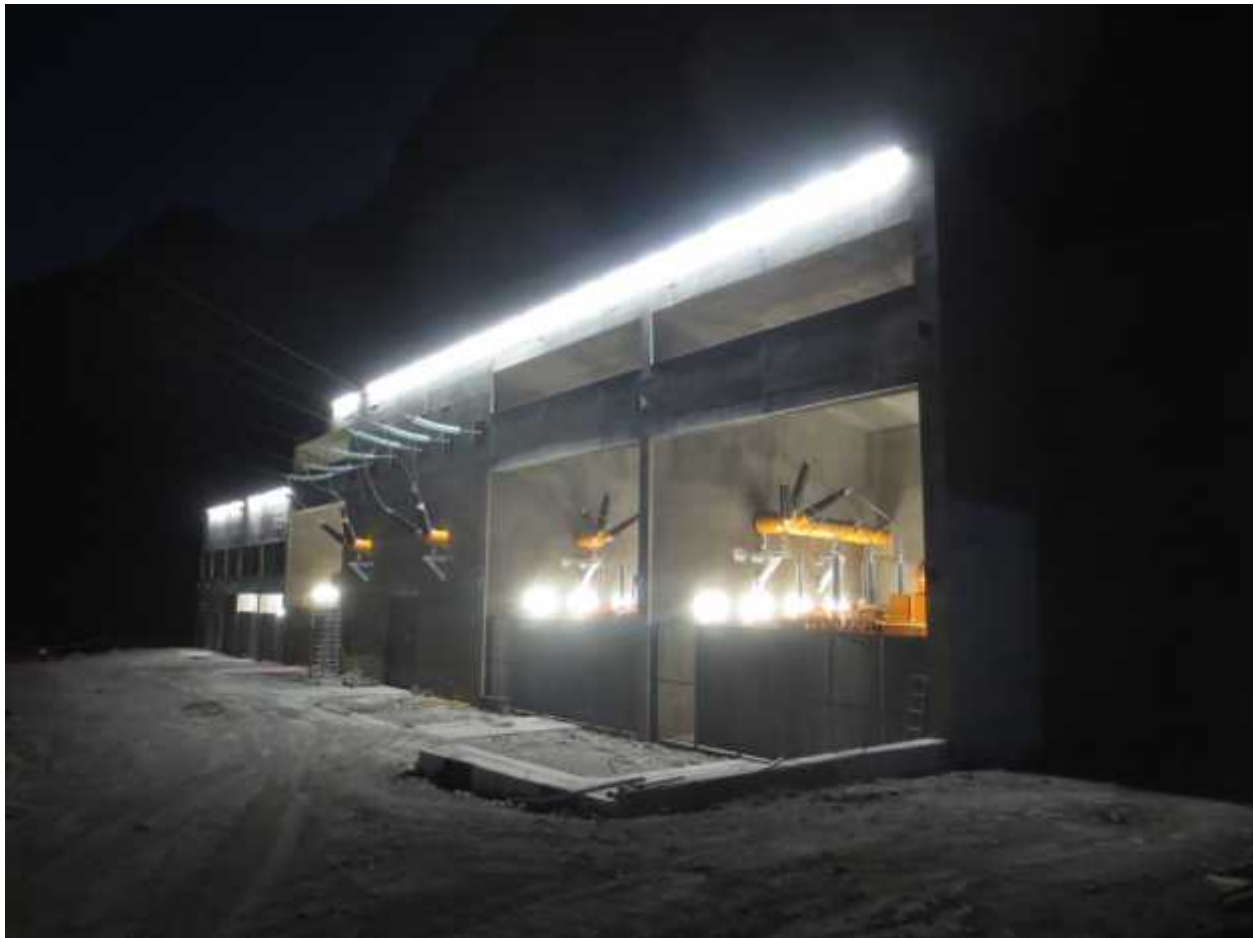
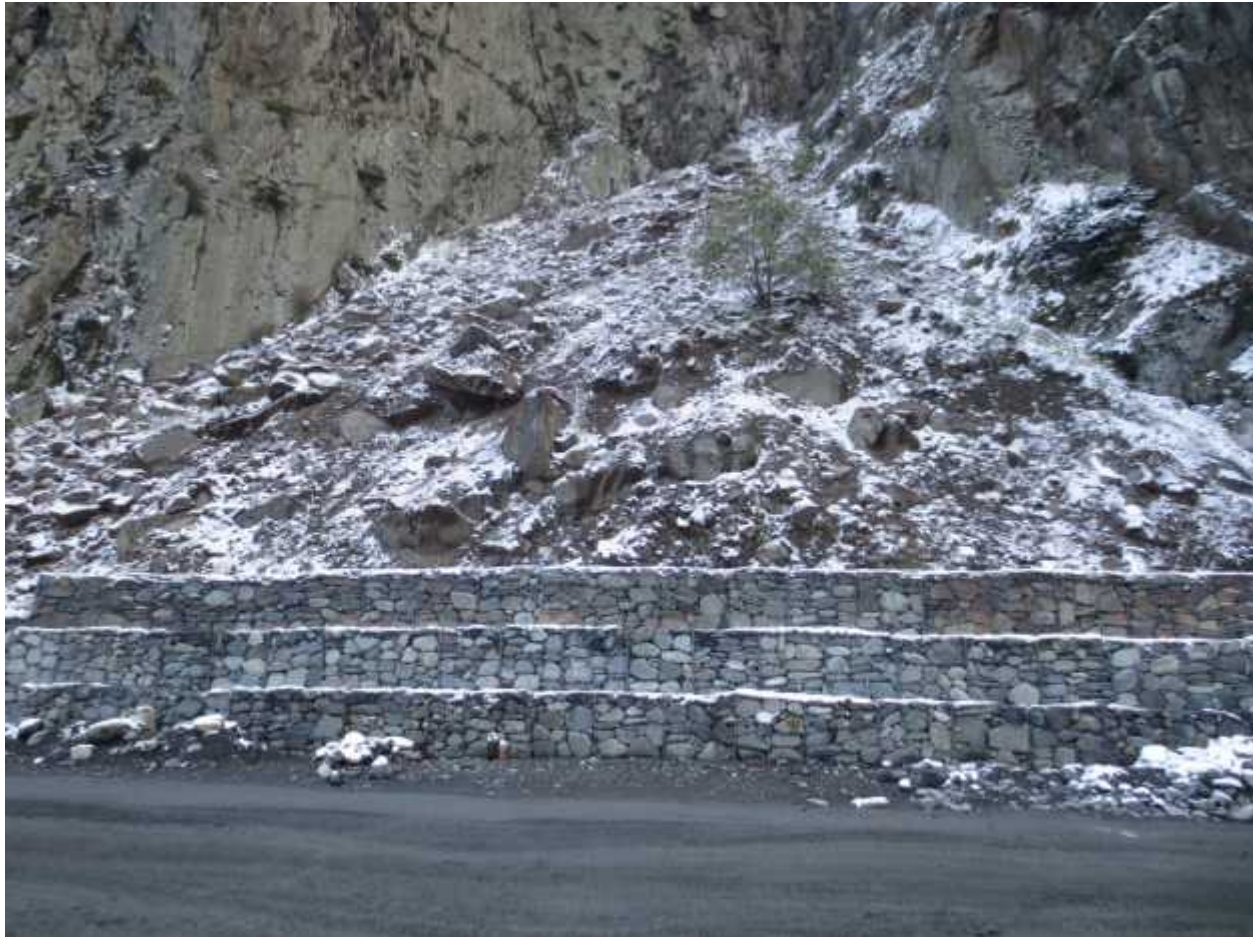
Area at cable portal was cleaned of waste and debris; oil spills; useless construction materials etc. Drainage control is maintained. Temporary and improperly installed electrical cables were removed. Final landscaping activities have been started.

Stones accumulated in the ravine beside of access tunnel were protected by metal wire mesh and gabion wall. This significantly decreased falling hazard, however as rockfall potential is inherent in these areas and on main public road which is only access and connection of the project headwork and Power Station facilities, additional caution should be taken when moving across unprotected areas.

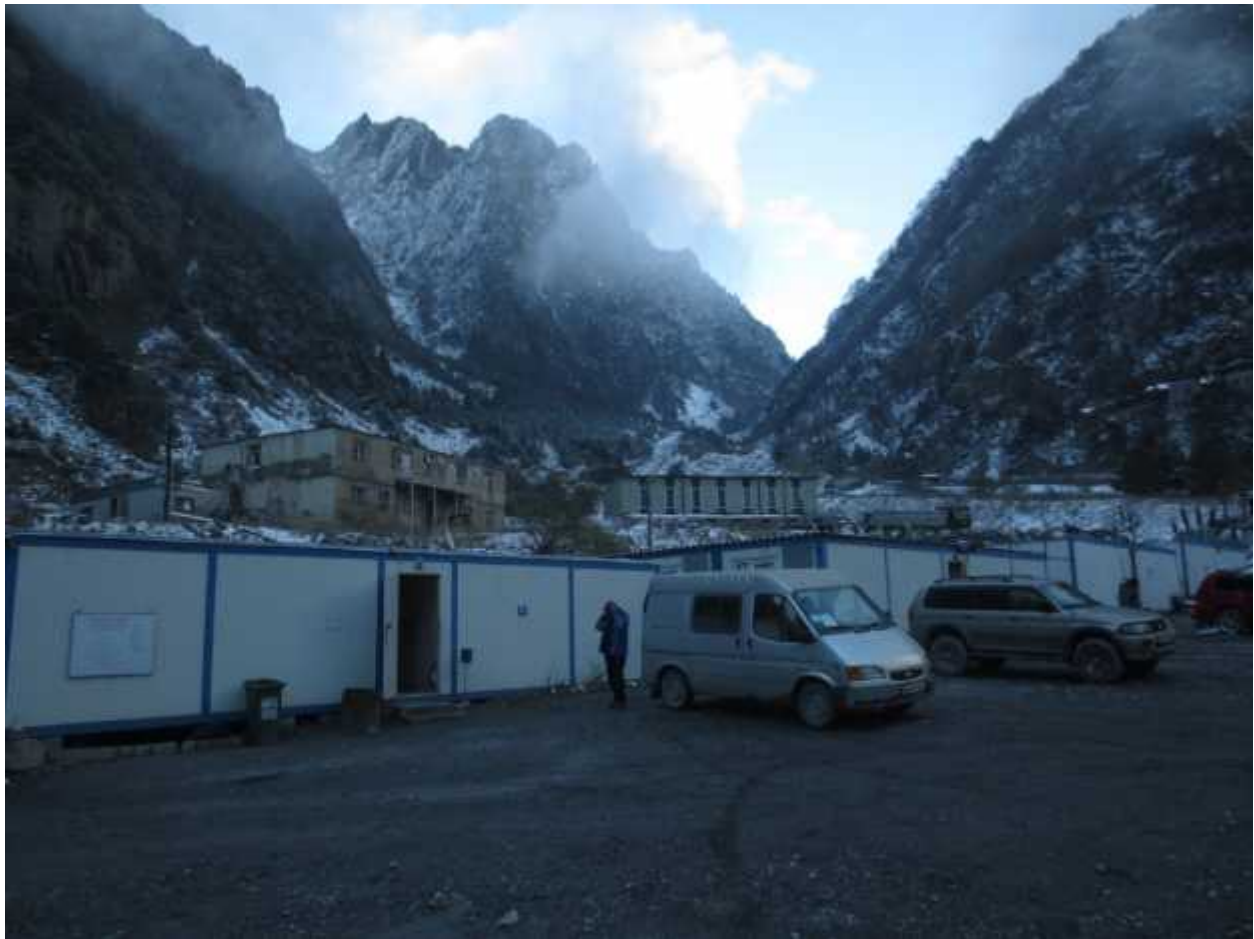
Commencement of reinstatement at camp site is expected after completing all other activities under the project. According contractor early summer of the next year is considered as winter associated natural events may hamper the reinstatement works.

Camp site reinstatement should be performed after site clearance. Temporary facilities will be removed, parking area and truck maintenance area will be cleared from minor spills. Area will be leveled and drainage channels will be installed. Natural re-vegetation should be monitored. Seeding will be performed if required. Disturbed areas will be reinstated to a condition as good, if not better than that that existed prior to establishment of the facilities, and will be to the satisfaction of the owner/authority.
