# Environmental Monitoring of Darial Hydropower Plant Construction and Operation

## Botanical Component

The first phase of the monitoring of the botanical component of the Darial hydropower plant construction and operation was carried out on 18 August, 2015

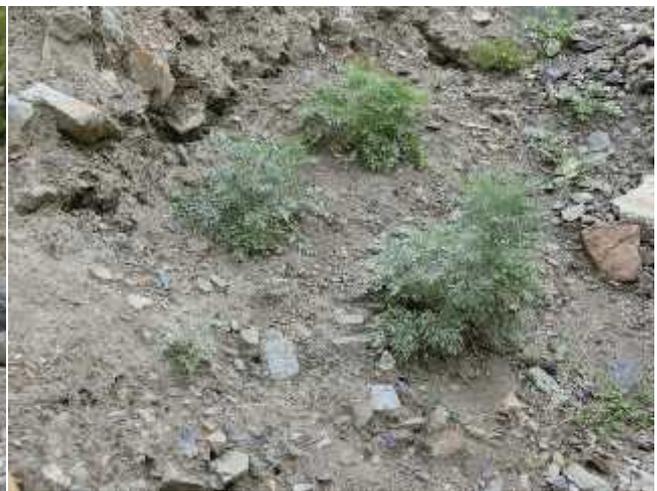
**Site 1.** *Artemisia absinthium*

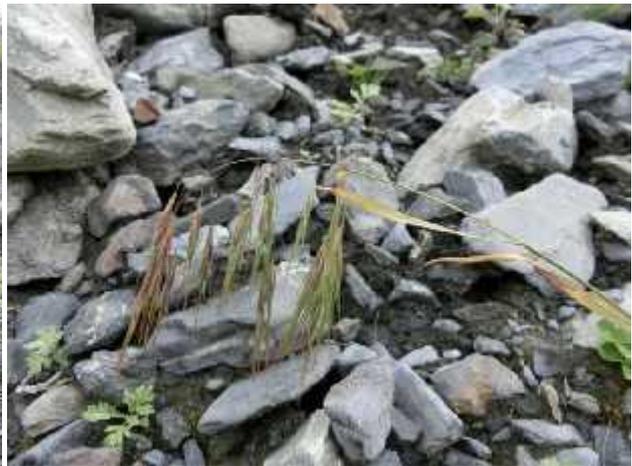
Site 3. *Bromopsis variegata*

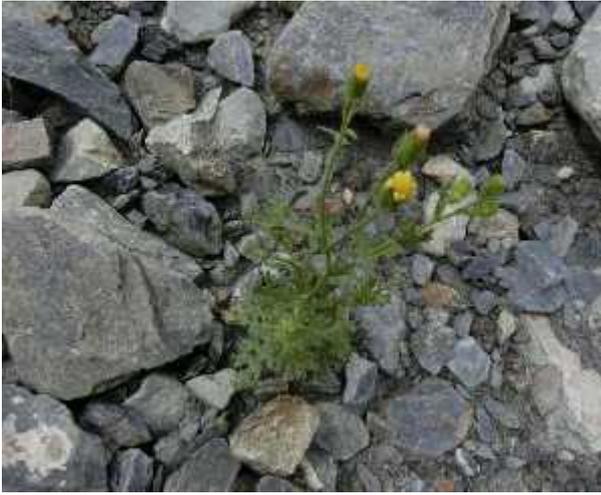
Site 4. GPS coordinates 0471236/4725456, 1698 m a.s.l. slope - 0°. The area of the power conduit below the debris cone on the Kuro slope. The pioneer phase of vegetation restoration on the rocky soil after construction is represented by the following plant species: *Artemisia absinthium*, *Cirsium* sp., *Senecio sosnowskyi-kavkasiis* endemi, *Nardus stricta*, *Polygonum aviculare*, *Poa pratensis*, *Xeranthemum squarrosum*, *Tussilago farfara*, *Carduus onopordioides*, *Chamerion dodonaei*. Below the pipeline way on the newly filled soil restoration of vegetation has not begun.

Site 4. *Senecio sosnowskyi*-Caucasian endemic

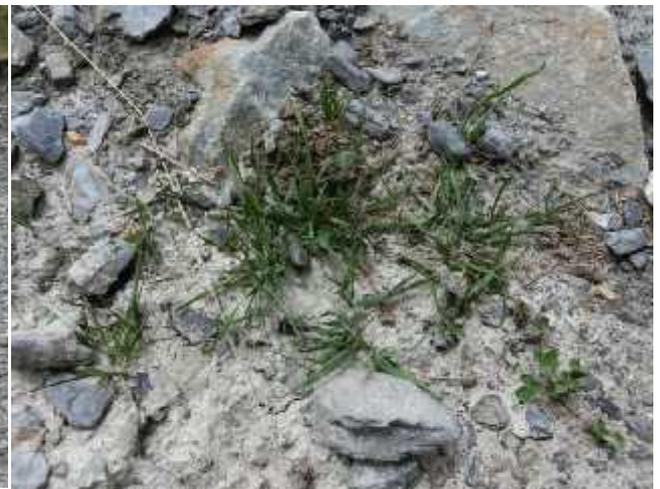
Site 5. *Poa* sp.

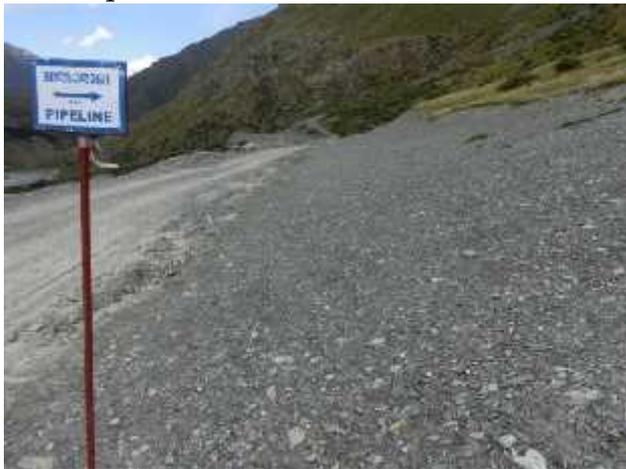
**Site 7.** GPS coordinates 0471216/4725010, 1704 m a.s.l. The situation similar to the two previous sites. The natural meadow turfs occupy the slope which are located as the landslide isles. The plant species are: *Taraxacum officinale*, *Agrostis planifolia*, *Bromopsis variegata*, *Festuca pratensis* and other.

**Site 7.** Design corridor

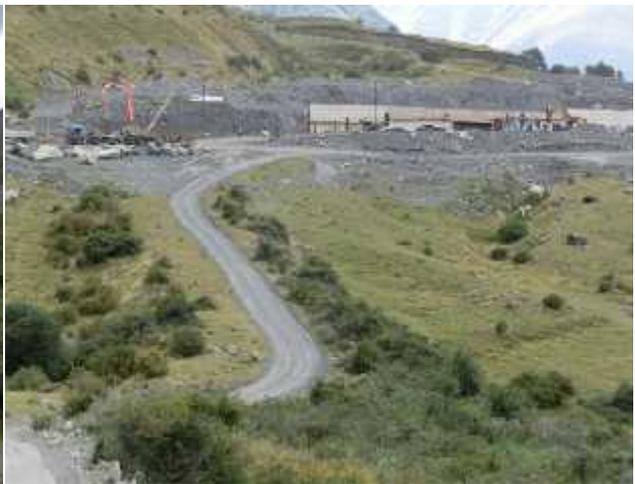
**Site 9.** Natural vegetation on both sides of the road – sea buckthorns subalpine meadows

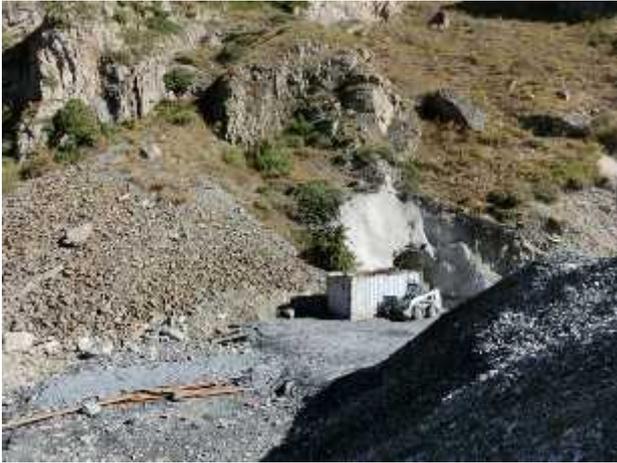
**Site 1.** From the portal of the pressure conduit (the Rock Feet site) on the post-construction stone-gravel soil there are yet the zero and initial phases of vegetation restoration. Here and there only pioneer plants are represented - *Artemisia absinthium*, *Festuca* sp., *Verbascum* sp., *Cirsium echinus-rozetis* stadiaze, *Hippophaë rhamnoides*.

Site 1. Areas of the upper portal of the pressure conduit tunnel

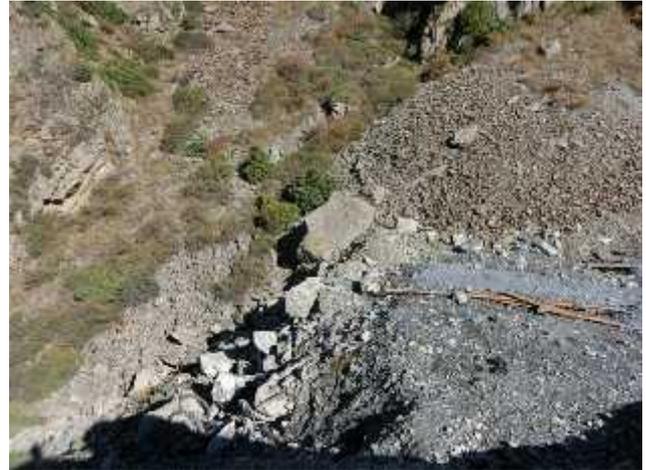
Site 1. Areas of the upper portal of the pressure conduit tunnel

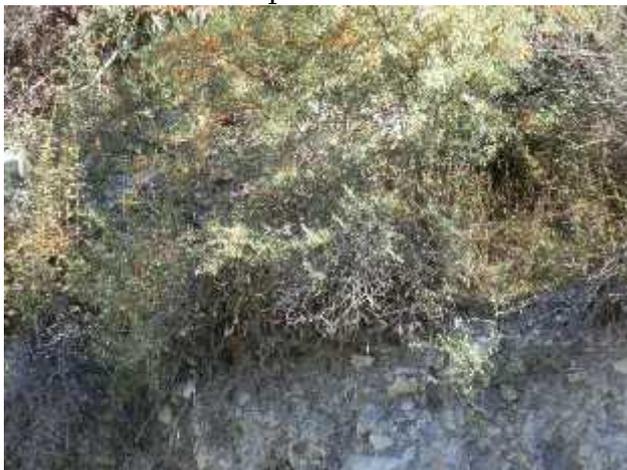
**Site 2.** Sea-buckthorn on the area adjacent to the construction corridor

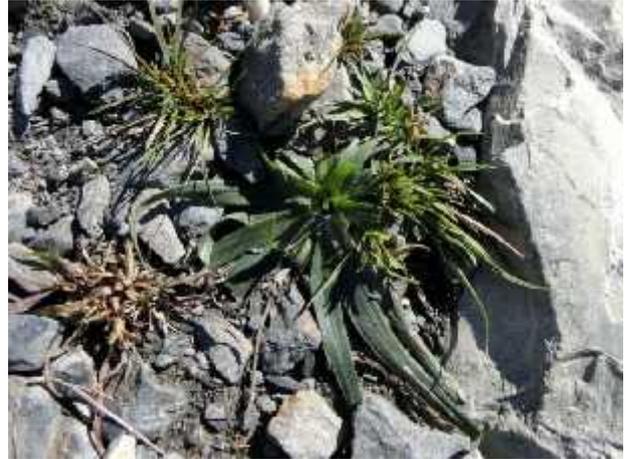
**Site 2.** *Plantago saxatilis*

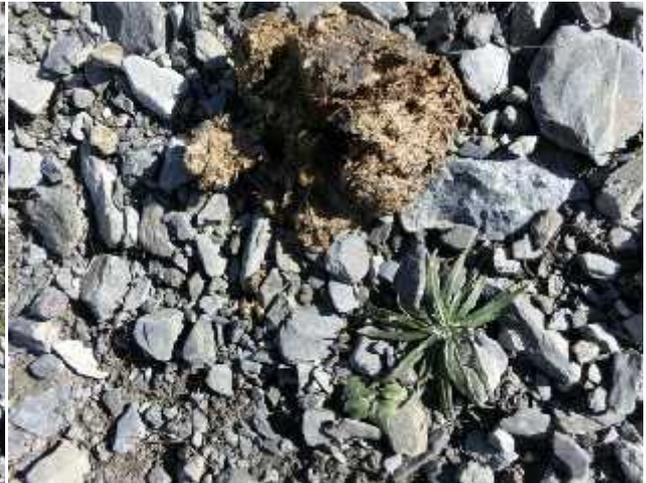
**Site 2.** *Plantago lanceolata*

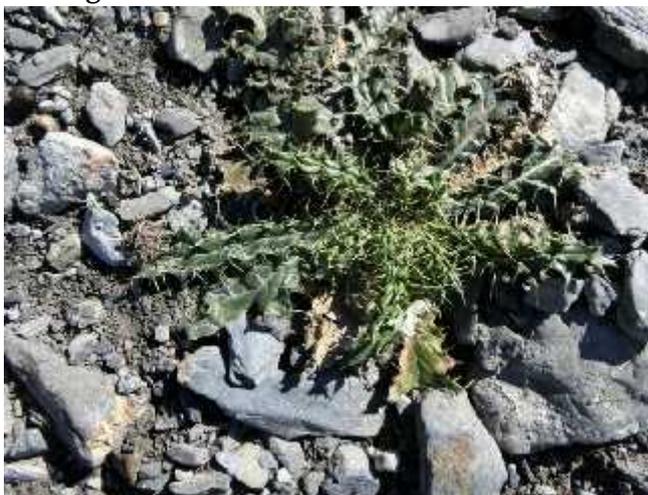
**Site 2.** *Cirsium echinus* rosettes

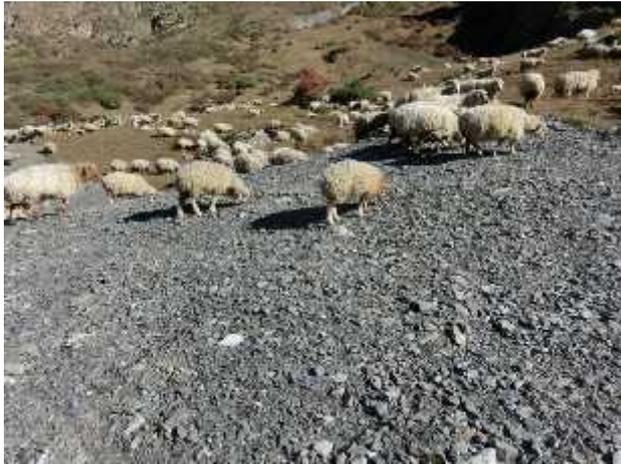
**Site 3.** In this section the sheep grazing is a hindering factor. The sheep paths and grazed pioneer plants are seen on the slopes.

**Site 3.** Sheep grazing in the designed corridor

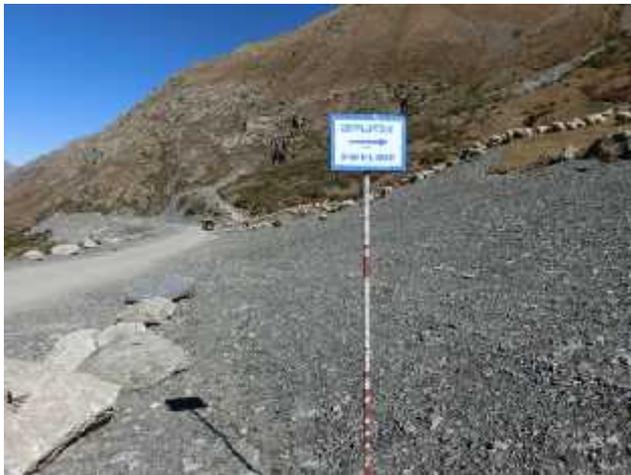
**Site 3.** Designed area

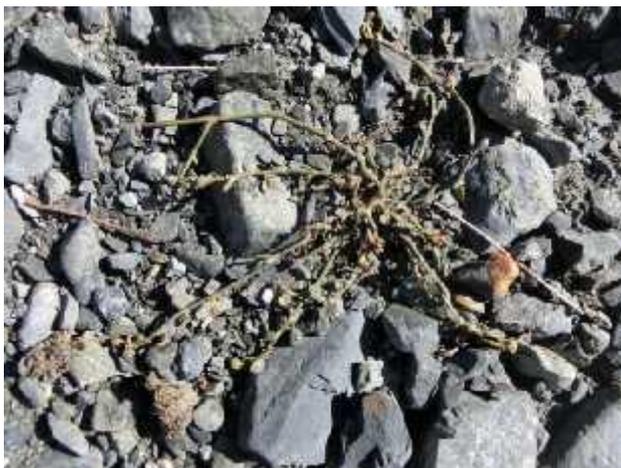
**Site 3.** *Polygonum aviculare*

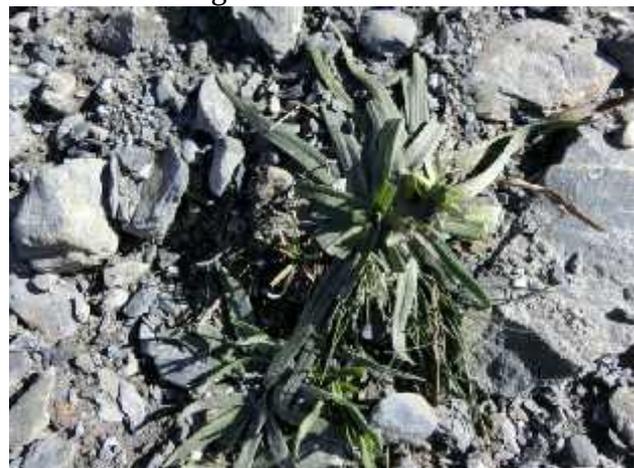
**Site 3.** *Plantago saxatilis*

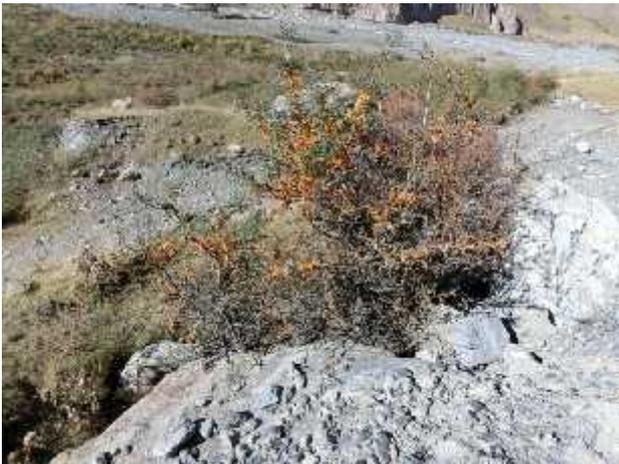
**Site 5.** Sea buckthorn on the area adjacent to the construction site

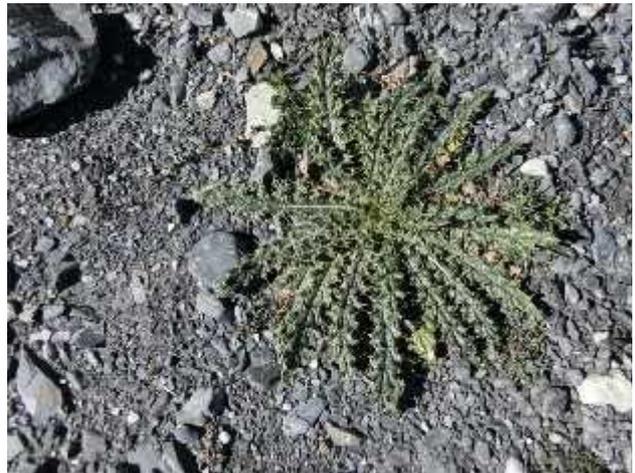
**Site 5.** *Carduus onopordioides*

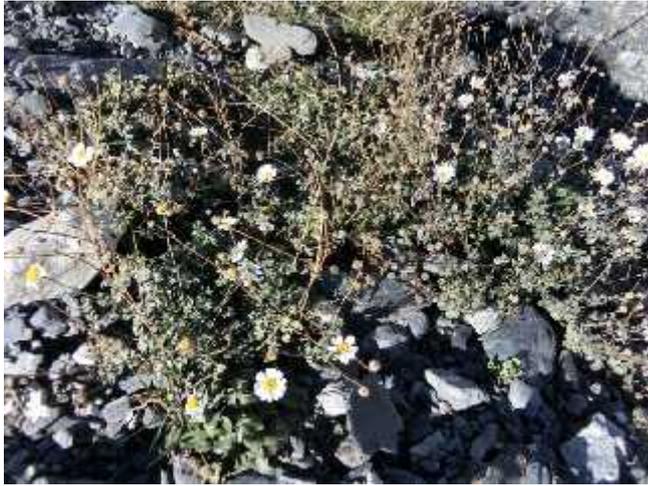
Site 5. *Pyrethrum fruticosum*

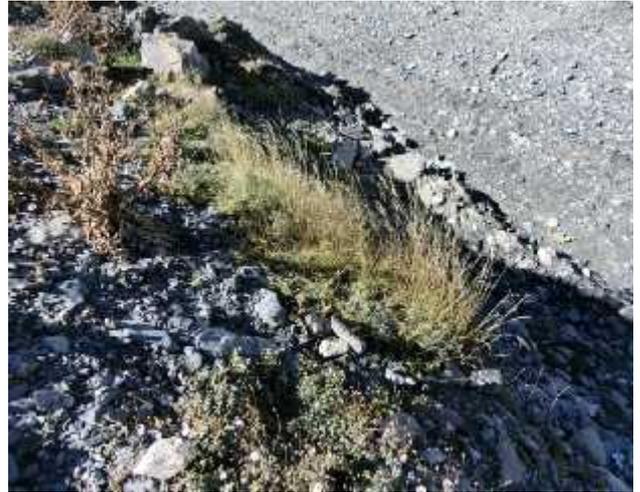
Site 5. *Festuca varia*

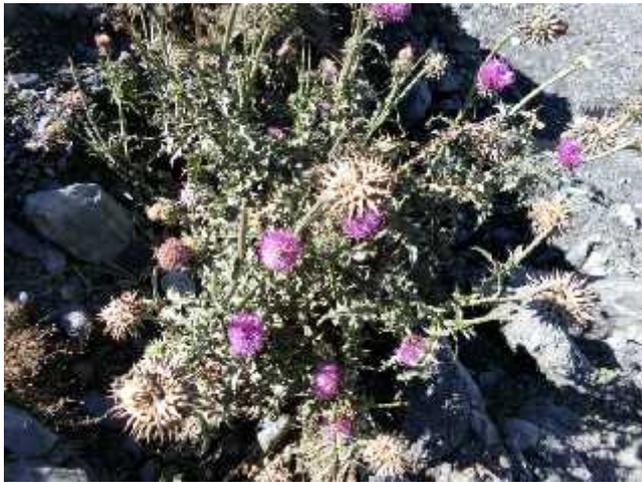
Site 5. *Carduus onopordioides*

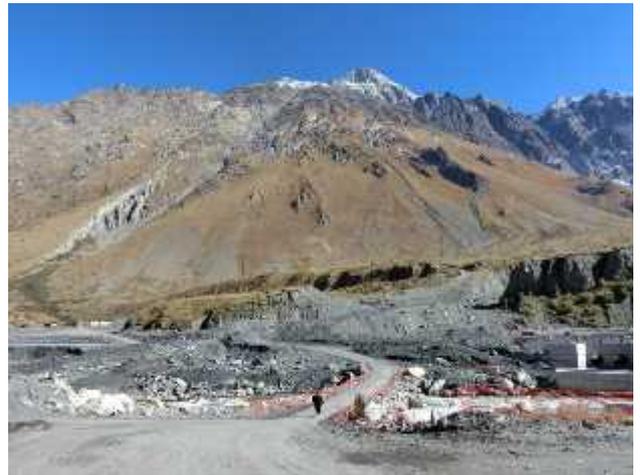
Site 5. Designed corridor

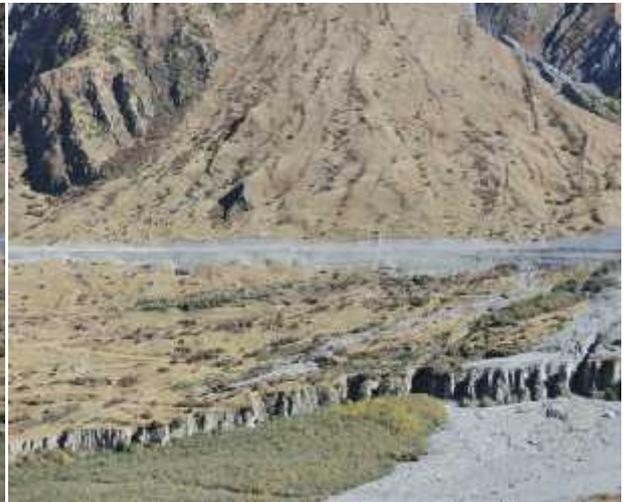
Site 5. Old landslide cone
